Access Compliance Report Public Rights-of-Way (Curb Ramps)

Intersection ID: 30347	Main Str	Main Street: GOLD_PAN_RD			eet:	SLICKROCK_CR	Location:	Ν			
ADA ID: E73B7920F79C	Ramp Ty	Ramp Type: Perp			s/Fa	il: Pass Overall	o Severity Score:	0			
Codes/Mitigation Info/Possible Solution					Field Measurements/Component Compliance						
11 1 1 1 1 1 1 1 1 1 1 1 1 1 1 1 1 1 1	all the second	Possible Solutions:		<u>c</u>	Compliance Description		Data Compliance Description		liance Description	Data	
A Contraction	ET A	Remove & Replace En	tire Ramp.	N	I/A	Ramp Length (in)	48.0	Yes	Ramp Slope (%)	7.2	
				Y	es	Ramp Width (in)	54.5	Yes	Ramp XSlope (%)	0.6

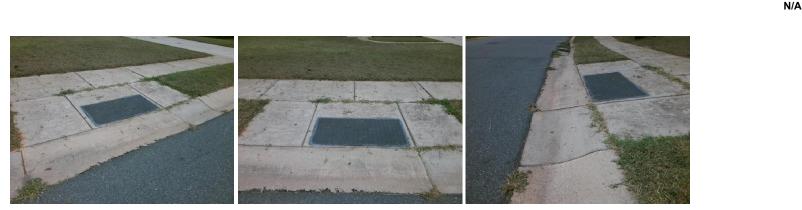
- And			Ν	/ A	Flare Type LT	Sloped	N/A	Flare Type RT	N/A	
				Ν	I/A	Flare Slope LT (%)	2.2	Yes	Flare Slope RT (%)	5.6	
				Ν	I/A	Flare Traversable LT?	Yes	N/A	Flare Traversable RT?	Yes	
				Y	es	Landing Length (in)	48.0	Yes	DWS Provided?	Yes	
	and white	Surveyor Notes:		Y	es	Landing Width (in)	48.0	Yes	DWS Contrast?	Yes	
COLD PAN RD	h	N/A		Ν	lo	Landing Slope (%)	2.4	Yes	DWS Length (in)	24.0	
				Y	es	Landing X Slope (%)	1.7	Yes	DWS Full Width?	Yes	
Le Contra	d.			Ν	I/A	Landing Curb? (Y/N)	No	Yes	DWS Offset (in)	2.0	
	A Pris			Ν	I/A	Shared Landing?	No				
	N N SE	PROW/ADA:		Y	'es	Gutter Ponding?	No	Yes	Gutter Slope (%)	3.0	
	12 1 1 1 1	Not Found, R304.2.2-P	erp. R304.3.	2- Y	es	Gutter Lip Ht (in)	0.0	Yes	Gutter X Slope (%)	0.1	
	AN AR	Para	• *		I/A	Painted X Walk1?	No	N/A	Painted X Walk2?	N/A	
						X Walk 1 Direction	To S		X Walk 2 Direction	N/A	
	A CT AND			Ν	I/A	X Walk 1 Width (in)	N/A	N/A	X Walk 2 Width (in)	N/A

Street 1 Name	GOLD PAN RD					X Walk 1 Slope (%)	3.0		X Walk 2 Slope (%)	N/A	
Stop Condition-Street 2	None					X Walk 1 X Slope (%)	0.7		X Walk 2 X Slope (%)	N/A	
Street 2 Name	N/A			Ν	I/A	Ramp inside XWalk1?	N/A	N/A	Ramp inside XWalk2?	N/A	
Stop Condition-Street 1	N/A					Road Slope (%)	N/A	N/A	Clear Space?	Yes	
						Road X Slope (%)	N/A	N/A	Clear Space to XWalk (in)	N/A	
				Y	'es	Any Obstructions?	No	Yes	Storm Grate/Utility Hazard?	No	
		Total Cost:	\$ 18	50.00		Obstruction Type			Storm Grate/Utility Type		
							N/A			N/A	
1								•
