# Access Compliance Report

## Public Rights-of-Way

### (Curb Ramps)

Intersection ID: 20377	Main Street: MORVEN_LN	Cross Street: WINGRAVE_DR	Location: W
ADA ID: E73FD12F0D05	Ramp Type: PerpDiag	Initial Pass/Fail: Fail	Overall Compliance: No
Severity Score: 33.75			
Codes/Mitigation Info/Possible Solution		Field Measurements/Component Compliance

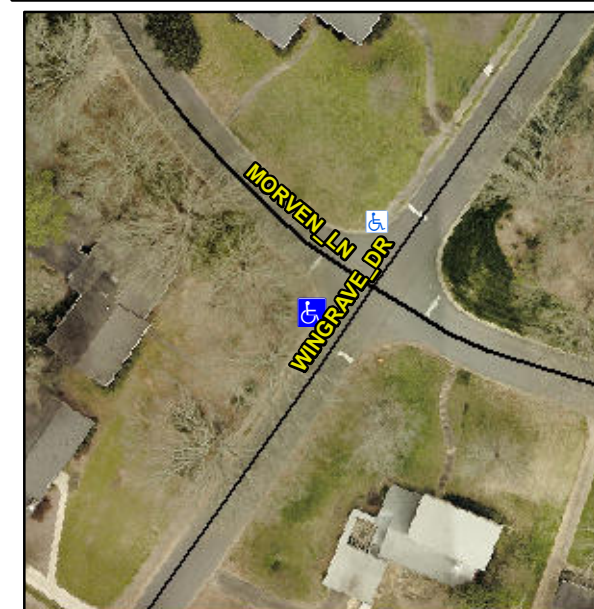
**Not Found, R304.5.1, R304.2.2, R304.5.3**

Compliance	Description	Data	Compliance	Description	Data
N/A	Ramp Length (in)	57.0	No	Ramp Slope (%)	10.6
No	Ramp Width (in)	46.0	No	Ramp XSlope (%)	6.2
N/A	Flare Type LT	N/A	N/A	Flare Type RT	N/A
N/A	Flare Slope LT (%)	N/A	N/A	Flare Slope RT (%)	N/A
N/A	Flare Traversable LT?	N/A	N/A	Flare Traversable RT?	N/A
N/A	Landing Length (in)	N/A	N/A	DWS Provided?	N/A
N/A	Landing Width (in)	N/A	N/A	DWS Contrast?	N/A
N/A	Landing Slope (%)	N/A	N/A	DWS Length (in)	N/A
N/A	Landing X Slope (%)	N/A	N/A	DWS Full Width?	N/A
N/A	Landing Curb? (Y/N)	N/A	N/A	DWS Offset (in)	N/A
N/A	Shared Landing?	N/A			
N/A	Gutter Ponding?	N/A	N/A	Gutter Slope (%)	N/A
N/A	Gutter Lip Ht (in)	N/A	N/A	Gutter X Slope (%)	N/A
N/A	Painted X Walk1?	No	N/A	Painted X Walk2?	No
	X Walk 1 Direction	To SE		X Walk 2 Direction	To NE
N/A	X Walk 1 Width (in)	N/A	N/A	X Walk 2 Width (in)	N/A
	X Walk 1 Slope (%)	0.2		X Walk 2 Slope (%)	1.6
	X Walk 1 X Slope (%)	2.6		X Walk 2 X Slope (%)	2.2

N/A	Ramp inside XWalk1?	N/A	N/A	Ramp inside XWalk2?	N/A
	Road Slope (%)	3.0	N/A	Clear Space?	N/A
	Road X Slope (%)	0.9	N/A	Clear Space to XWalk (in)	N/A
N/A	Any Obstructions?	N/A	N/A	Storm Grate/Utility Hazard?	N/A
	Obstruction Type			Storm Grate/Utility Type	
		N/A			N/A
			Yes	Surface Condition? (G/P)	Good

**Remove & Replace Curb Ramp With Two New Directional Ramps or Equivalent.**
