# Access Compliance Report

## Public Rights-of-Way

### (Curb Ramps)

| Intersection ID: 53899 | Main Street: LANGWELL_LN | Cross Street: ELGIN_MOOR_RD | Location: NW |

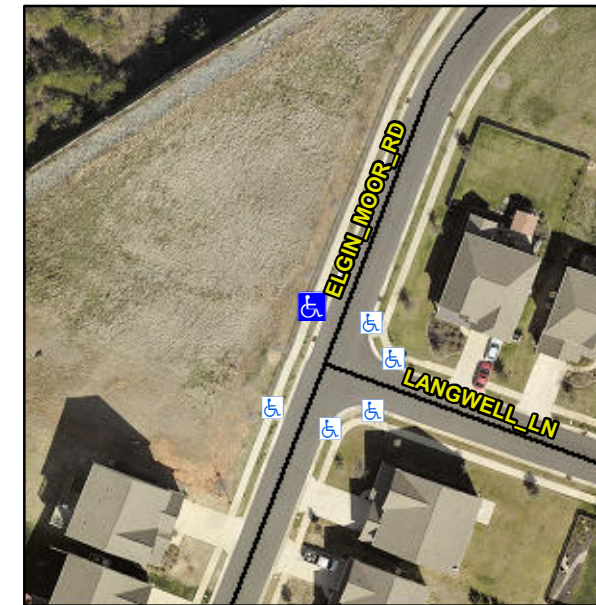
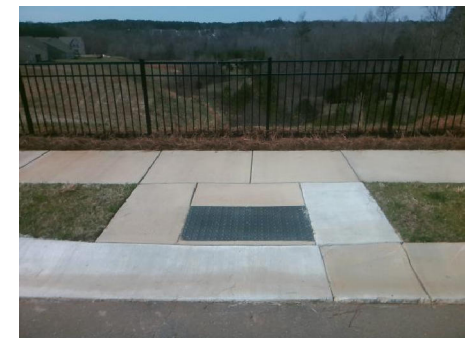
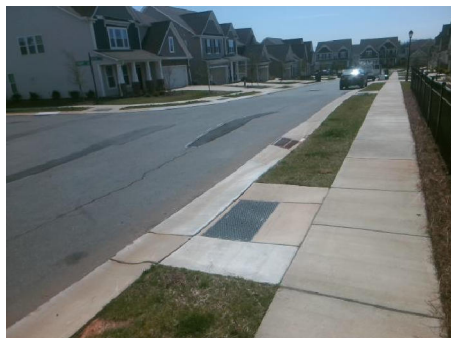
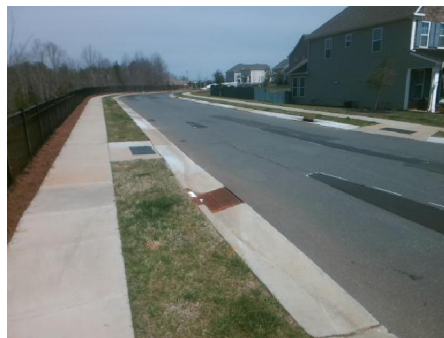
| ADA ID: E74E2D5517AD | Ramp Type: BlendTrans1 | Initial Pass/Fail: Fail | Overall Compliance: No |
| | | Severity Score: 10 | |

**Not Found, R304.5.1, R304.5.3**

| Compliance | Description | Data | Compliance | Description | Data |
|---|---|---|---|---|---|
| N/A | Ramp Length (in) | 48.0 | Yes | BlendTrans Slope (%) | 3.3 |
| No | Ramp Width (in) | 47.0 | No | BlendTrans XSlope (%) | 3.6 |
| | | | No | Curb Slope (%) | 8.6 |

Possible Solutions:

**Remove & Replace Curb Ramp With Two New Directional Ramps or Equivalent.**

Total Cost: \$ 3200.00
