Access Compliance Report

Public Rights-of-Way

(Curb Ramps)

| Intersection ID: 10018432 | Main Street: WITHAM PASSAGE | Cross Street: N/A | Location: E |

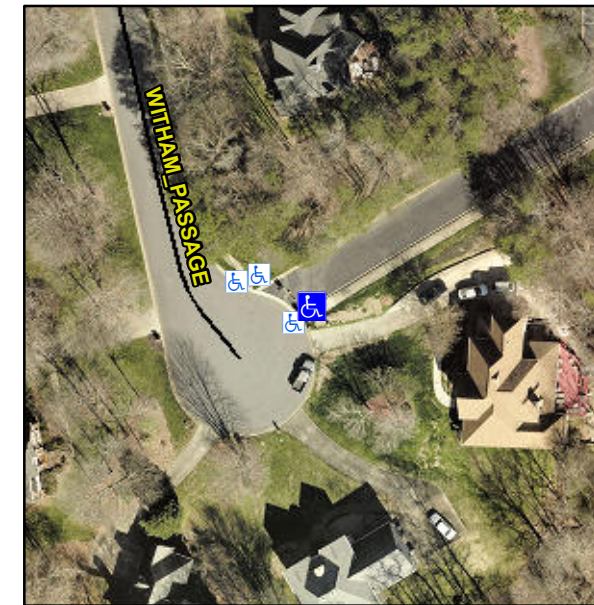
| ADA ID: E74FE6F5E17D | Ramp Type: Para | Initial Pass/Fail: Fail | Overall Compliance: No |
| | | | Severity Score: 26.25 |

R304.3.2, R304.5.3

| Compliance | Description | Data | Compliance | Description | Data |
|---|---|---|---|---|---|
| No | Ramp Slope LT (%) | 15.3 | No | Ramp Slope RT (%) | 12.5 |
| Yes | Ramp XSlope LT (%) | 1.1 | No | Ramp XSlope RT (%) | 4.3 |

Remove & Replace Entire Ramp.
