# Access Compliance Report

## Public Rights-of-Way

### (Curb Ramps)

Intersection ID: 26470	Main Street: THORNBUSH_CT	Cross Street: WINTHROP_RIDGE_RD	Location: NW
ADA ID: E758E0E7CA48	Ramp Type: Perp	Initial Pass/Fail: Fail	Overall Compliance: No
		Severity Score: 12.5

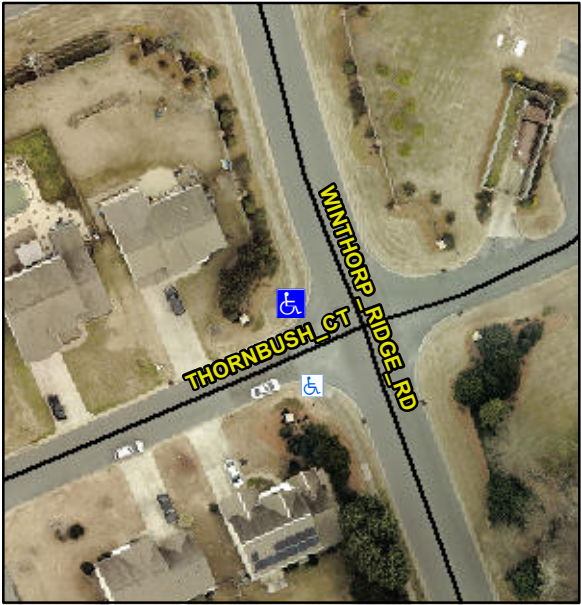
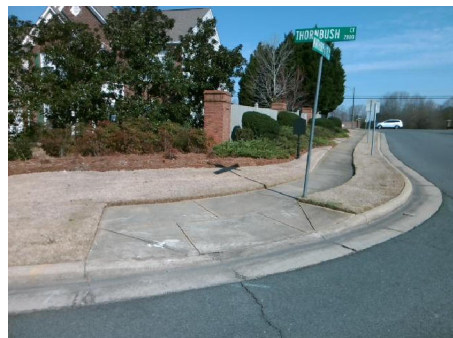
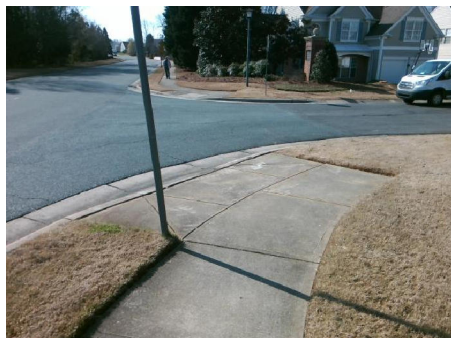
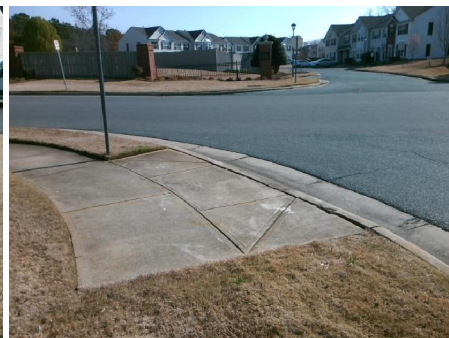
Possible Solutions:						
	Remove & Replace Entire Ramp.						
	Surveyor Notes:						
	N/A						
	PROW/ADA:						
	Not Found, R304.5.3						
		Compliance	Description	Data	Compliance	Description	Data
		N/A	Ramp Length (in)	49.5	Yes	Ramp Slope (%)	6.5
		Yes	Ramp Width (in)	48.0	No	Ramp XSlope (%)	5.5
		N/A	Flare Type LT	N/A	N/A	Flare Type RT	N/A
		N/A	Flare Slope LT (%)	N/A	N/A	Flare Slope RT (%)	N/A
		N/A	Flare Traversable LT?	N/A	N/A	Flare Traversable RT?	N/A
		N/A	Landing Length (in)	N/A	N/A	DWS Provided?	N/A
		N/A	Landing Width (in)	N/A	N/A	DWS Contrast?	N/A
		N/A	Landing Slope (%)	N/A	N/A	DWS Length (in)	N/A
		N/A	Landing X Slope (%)	N/A	N/A	DWS Full Width?	N/A
		N/A	Landing Curb? (Y/N)	N/A	N/A	DWS Offset (in)	N/A
		N/A	Shared Landing?	N/A			
		N/A	Gutter Ponding?	N/A	N/A	Gutter Slope (%)	N/A
		N/A	Gutter Lip Ht (in)	N/A	N/A	Gutter X Slope (%)	N/A

N/A	Painted X Walk1?	No	N/A	Painted X Walk2?	N/A
			X Walk 1 Direction	To S		X Walk 2 Direction	N/A
		N/A	X Walk 1 Width (in)	N/A	N/A	X Walk 2 Width (in)	N/A
			X Walk 1 Slope (%)	1.7		X Walk 2 Slope (%)	N/A
			X Walk 1 X Slope (%)	2.4		X Walk 2 X Slope (%)	N/A
		N/A	Ramp inside XWalk1?	N/A	N/A	Ramp inside XWalk2?	N/A
			Road Slope (%)	N/A	N/A	Clear Space?	N/A
			Road X Slope (%)	N/A	N/A	Clear Space to XWalk (in)	N/A
		N/A	Any Obstructions?	N/A	N/A	Storm Grate/Utility Hazard?	N/A
			Obstruction Type			Storm Grate/Utility Type	
					N/A		N/A
					Yes	Surface Condition? (G/P)	Good

Total Cost: \$ 1850.00
