Access Compliance Report

Public Rights-of-Way

(Curb Ramps)

Intersection ID: 50604	Main Street: RHODORA_RD	Cross Street: LAMINA_CT	Location: SE
ADA ID: E7667E98C235	Ramp Type: Perp	Initial Pass/Fail: Fail	Overall Compliance: No
Severity Score: 21.25			
Codes/Mitigation Info/Possible Solution		Field Measurements/Component Compliance

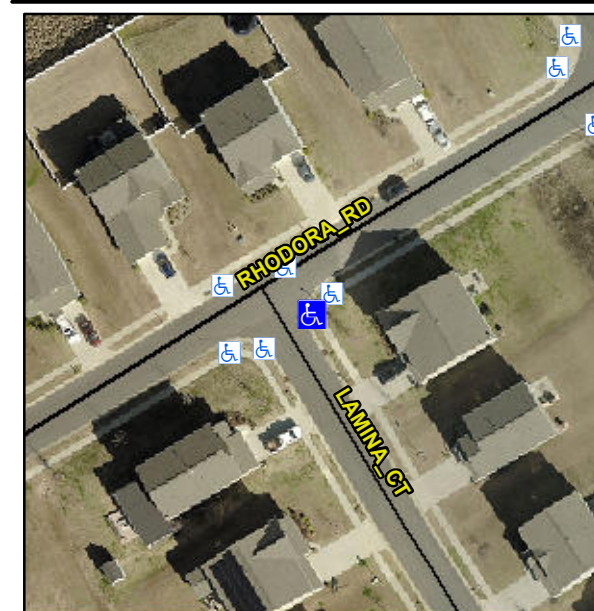
Not Found, R304.5.1, R304.2.2

Compliance	Description	Data	Compliance	Description	Data
N/A	Ramp Length (in)	48.5	No	Ramp Slope (%)	9.3
No	Ramp Width (in)	47.0	Yes	Ramp XSlope (%)	1.6
N/A	Flare Type LT	N/A	N/A	Flare Type RT	N/A
N/A	Flare Slope LT (%)	N/A	N/A	Flare Slope RT (%)	N/A
N/A	Flare Traversable LT?	N/A	N/A	Flare Traversable RT?	N/A
N/A	Landing Length (in)	N/A	N/A	DWS Provided?	N/A
N/A	Landing Width (in)	N/A	N/A	DWS Contrast?	N/A
N/A	Landing Slope (%)	N/A	N/A	DWS Length (in)	N/A
N/A	Landing X Slope (%)	N/A	N/A	DWS Full Width?	N/A
N/A	Landing Curb? (Y/N)	N/A	N/A	DWS Offset (in)	N/A
N/A	Shared Landing?	N/A			
N/A	Gutter Ponding?	N/A	N/A	Gutter Slope (%)	N/A
N/A	Gutter Lip Ht (in)	N/A	N/A	Gutter X Slope (%)	N/A
N/A	Painted X Walk1?	No	N/A	Painted X Walk2?	N/A
	X Walk 1 Direction	To W		X Walk 2 Direction	N/A
N/A	X Walk 1 Width (in)	N/A	N/A	X Walk 2 Width (in)	N/A
	X Walk 1 Slope (%)	0.6		X Walk 2 Slope (%)	N/A
	X Walk 1 X Slope (%)	1.1		X Walk 2 X Slope (%)	N/A

N/A	Ramp inside XWalk1?	N/A	N/A	Ramp inside XWalk2?	N/A
	Road Slope (%)	N/A	N/A	Clear Space?	N/A
	Road X Slope (%)	N/A	N/A	Clear Space to XWalk (in)	N/A
N/A	Any Obstructions?	N/A	N/A	Storm Grate/Utility Hazard?	N/A
	Obstruction Type			Storm Grate/Utility Type	
		N/A			N/A
			Yes	Surface Condition? (G/P)	Good

Possible Solutions:

Remove & Replace Entire Ramp.
