Access Compliance Report

Public Rights-of-Way

| Intersection ID: 18567 | Main Street: MICHAEL_BAKER_PL | Cross Street: RUNNYMEDE_LN | Location: NE |
| ADA ID: E76DE60FF841 | Ramp Type: Perp | Initial Pass/Fail: Fail | Overall Compliance: No |

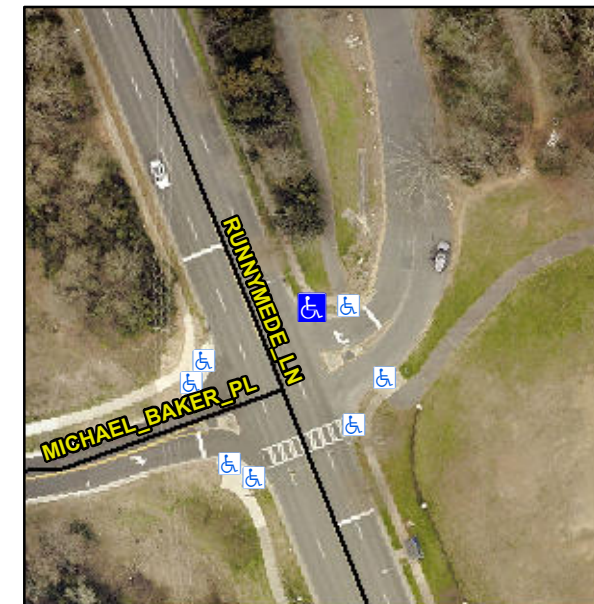
| Severity Score: 22.5 | | | |

R304.5.1, R304.2.2, R304.5.3

| Compliance | Description | Data | Compliance | Description | Data |
|---|---|---|---|---|---|
| N/A | Ramp Length (in) | 48.0 | No | Ramp Slope (%) | 11.7 |
| No | Ramp Width (in) | 47.0 | No | Ramp XSlope (%) | 2.9 |

Remove & Replace Entire Ramp.
