# Access Compliance Report

## Public Rights-of-Way

### (Curb Ramps)

Intersection ID: 5525	Main Street: W_W_T_HARRIS_BV	Cross Street: MCCULLOUGH_DR	Location: W
ADA ID: E771AA368492	Ramp Type: Combination2	Initial Pass/Fail: Fail	Overall Compliance: No
			Severity Score: 13.75

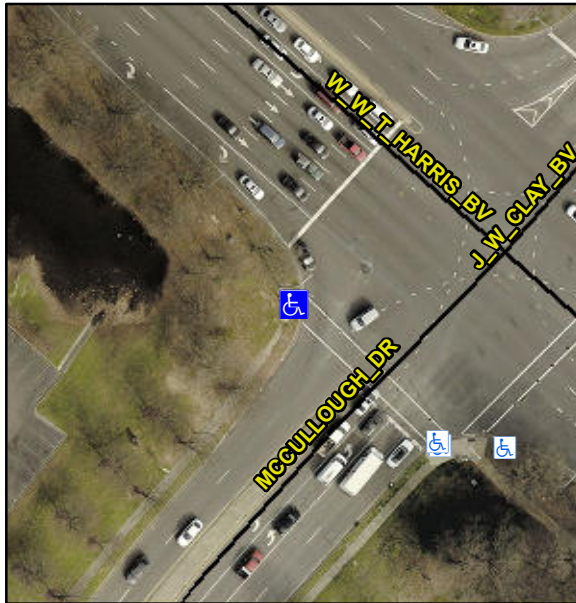
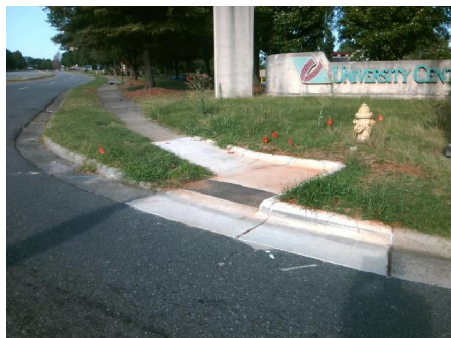
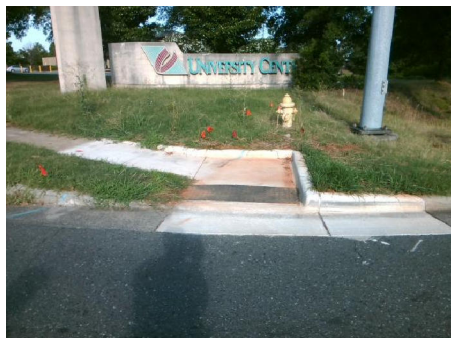
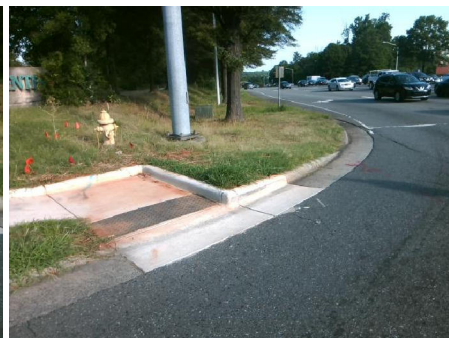
**NO CURB**

Compliance	Description	Data	Compliance	Description	Data
N/A	Ramp Length LT (in)	87.5	N/A	Ramp Length RT (in)	N/A
Yes	Ramp Width LT (in)	51.0	N/A	Ramp Width RT (in)	N/A
No	Ramp Slope LT (%)	8.5	N/A	Ramp Slope RT (%)	N/A
No	Ramp XSlope LT (%)	4.4	N/A	Ramp XSlope RT (%)	N/A
N/A	Ramp Length (in)	36.0	No	Ramp Slope (%)	8.5
Yes	Ramp Width (in)	58.0	Yes	Ramp XSlope (%)	0.2
N/A	Flare Type LT	N/A	N/A	Flare Type RT	N/A
N/A	Flare Slope LT (%)	N/A	N/A	Flare Slope RT (%)	N/A
N/A	Flare Traversable LT?	N/A	N/A	Flare Traversable RT?	N/A
N/A	Landing Length (in)	N/A	N/A	DWS Provided?	N/A
N/A	Landing Width (in)	N/A	N/A	DWS Contrast?	N/A
N/A	Landing Slope (%)	N/A	N/A	DWS Length (in)	N/A
N/A	Landing X Slope (%)	N/A	N/A	DWS Full Width?	N/A
N/A	Landing Curb? (Y/N)	N/A	N/A	DWS Offset (in)	N/A
N/A	Shared Landing?	N/A			
N/A	Gutter Ponding?	N/A	N/A	Gutter Slope (%)	N/A
N/A	Gutter Lip Ht (in)	N/A	N/A	Gutter X Slope (%)	N/A
N/A	Painted X Walk1?	No	N/A	Painted X Walk2?	N/A

X Walk 1 Direction	To SE		X Walk 2 Direction	N/A
	X Walk 1 Width (in)	N/A		X Walk 2 Width (in)	N/A
	X Walk 1 Slope (%)	0.7		X Walk 2 Slope (%)	N/A
	X Walk 1 X Slope (%)	2.4		X Walk 2 X Slope (%)	N/A
N/A	Ramp inside XWalk1?	N/A	N/A	Ramp inside XWalk2?	N/A
	Road Slope (%)	N/A		Clear Space?	N/A
	Road X Slope (%)	N/A	N/A	Clear Space to XWalk (in)	N/A
			N/A	Any Obstruction?	N/A
				Obstruction Type	N/A
			N/A	Storm Grate/Utility Hazard?	N/A
				Storm Grate/Utility Type	N/A
					N/A
Yes	Surface Condition? (G/P)	Good			
	Curb Slope (%)	N/A

**Remove & Replace Entire Ramp.**

**R304.2.2, R304.3.2, R304.5.3**
