Good

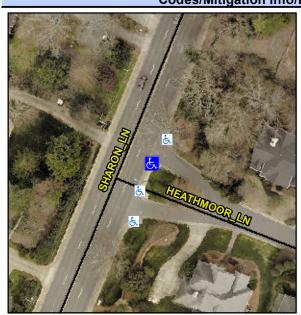
Total Cost: 3200.00

Field Measurements/Component Compilance						
Compliance Description		Data	Comp	liance	Description	Data
N/A	Ramp Length (in)	58.5	Yes	Ram	Slope (%)	6.5
No	Ramp Width (in)	34.0	Yes	Ramp	XSlope (%)	0.0
N/A	Flare Type LT	N/A	N/A Flare Type RT		N/A	
N/A	Flare Slope LT (%)	N/A	N/A Flare Slope RT (%)		N/A	
N/A	Flare Traversable LT?	N/A	N/A	Flare	Traversable RT?	N/A
N/A	Landing Length (in)	N/A	N/A	DWS	Provided?	N/A
N/A	Landing Width (in)	N/A	N/A	DWS	Contrast?	N/A
N/A	Landing Slope (%)	N/A	N/A	DWS	Length (in)	N/A
N/A	Landing X Slope (%)	N/A	N/A	DWS	Full Width?	N/A
N/A	Landing Curb? (Y/N)	N/A	N/A	DWS	Offset (in)	N/A
N/A	Shared Landing?	N/A				
N/A	Gutter Ponding?	N/A	N/A	Gutte	er Slope (%)	N/A
N/A	Gutter Lip Ht (in)	N/A	N/A	Gutte	er X Slope (%)	N/A
N/A	Painted X Walk1?	No	N/A	Paint	ed X Walk2?	No
	X Walk 1 Direction	To NE		X Wa	lk 2 Direction	To NW
N/A	X Walk 1 Width (in)	N/A	N/A	X Wa	lk 2 Width (in)	N/A
	X Walk 1 Slope (%)	0.2		X Wa	lk 2 Slope (%)	2.1
