## **Access Compliance Report Public Rights-of-Way** (Curb Ramps)

Intersection ID: 30121 Main Street: CLOONEY\_LN Cross Street: VERNON\_WOOD\_LN Location: S 10 ADA ID: E78564A8D8E6 Ramp Type: Perp Initial Pass/Fail: Fail **Overall Compliance: No Severity Score:**

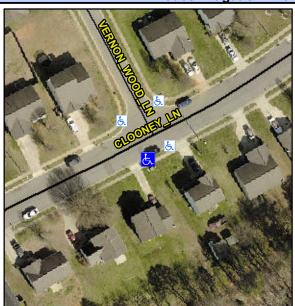
Field Measurements/Component Compliance								
Comp	liance Description	Data	Comp	liance	Description	Data		
N/A	Ramp Length (in)	48.0	Yes	Ramp	Slope (%)	6.0		
No	Ramp Width (in)	38.5	No	Ramp	XSlope (%)	4.5		
N/A	Flare Type LT	N/A	N/A	Flare	Type RT	N/A		
N/A	Flare Slope LT (%)	N/A	N/A	Flare	Slope RT (%)	N/A		
N/A	Flare Traversable LT?	N/A	N/A	Flare	Traversable RT?	N/A		
N/A	Landing Length (in)	N/A	N/A	DWS	Provided?	N/A		
N/A	Landing Width (in)	N/A	N/A	DWS	Contrast?	N/A		
N/A	Landing Slope (%)	N/A	N/A	DWS	Length (in)	N/A		
N/A	Landing X Slope (%)	N/A	N/A	DWS	Full Width?	N/A		
N/A	Landing Curb? (Y/N)	N/A	N/A	DWS	Offset (in)	N/A		
N/A	Shared Landing?	N/A						
N/A	Gutter Ponding?	N/A	N/A	Gutte	er Slope (%)	N/A		
N/A	Gutter Lip Ht (in)	0.5	N/A	Gutte	r X Slope (%)	N/A		
N/A	Painted X Walk1?	No	N/A	Paint	ed X Walk2?	N/A		
	X Walk 1 Direction	To N		X Wa	lk 2 Direction	N/A		
N/A	X Walk 1 Width (in)	N/A	N/A	X Wa	lk 2 Width (in)	N/A

X Walk 1 Slope (%)	3.9		X Wa	lk 2 Slope (%)	N/A		
	X Walk 1 X Slope (%)	3.4		X Wa	lk 2 X Slope (%)	N/A		
N/A	Ramp inside XWalk1?	N/A	N/A	Ram	inside XWalk2?	N/A		
	Road Slope (%)	N/A	N/A	Clear	Space?	N/A		
	Road X Slope (%)	N/A	N/A	Clear	Space to XWalk (in)	N/A		
N/A	Any Obstructions?	N/A	N/A	Storn	n Grate/Utility Hazard?	N/A		
	Obstruction Type			Storn	n Grate/Utility Type			
		N/A				N/A		
			Yes	Surfa	ce Condition? (G/P)	Good

Possible Solution	
Possible Solutions:	Col
Remove & Replace Entire Ramp.	N/A
·	No
	N/A
	N/A
	N/A
	N/A
Surveyor Notes:	N/A
N/A	N/A
	N/A
	N/A
	N/A
PROW/ADA:	N/A
R304.5.1, R304.5.3	N/A
•	N/A
	N/A

Total Cost: 1850.00
