# Access Compliance Report

## Public Rights-of-Way

### (Curb Ramps)

Intersection ID: 24936	Main Street: CARMEL_RD	Cross Street: CARMEL_FOREST_DR	Location: W
ADA ID: E785901D243D	Ramp Type: PerpDiag	Initial Pass/Fail: Fail	Overall Compliance: No
Severity Score: 22.5			
Codes/Mitigation Info/Possible Solution		Field Measurements/Component Compliance

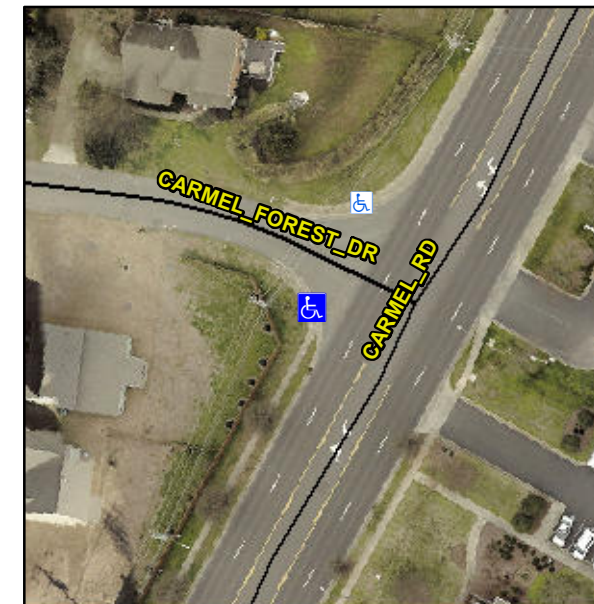
**Not Found, R304.5.1, R304.2.2, R304.5.3**

Compliance	Description	Data	Compliance	Description	Data
N/A	Ramp Length (in)	60.0	No	Ramp Slope (%)	8.9
No	Ramp Width (in)	43.0	No	Ramp XSlope (%)	3.0
N/A	Flare Type LT	N/A	N/A	Flare Type RT	N/A
N/A	Flare Slope LT (%)	N/A	N/A	Flare Slope RT (%)	N/A
N/A	Flare Traversable LT?	N/A	N/A	Flare Traversable RT?	N/A
N/A	Landing Length (in)	N/A	N/A	DWS Provided?	N/A
N/A	Landing Width (in)	N/A	N/A	DWS Contrast?	N/A
N/A	Landing Slope (%)	N/A	N/A	DWS Length (in)	N/A
N/A	Landing X Slope (%)	N/A	N/A	DWS Full Width?	N/A
N/A	Landing Curb? (Y/N)	N/A	N/A	DWS Offset (in)	N/A
N/A	Shared Landing?	N/A			
N/A	Gutter Ponding?	N/A	N/A	Gutter Slope (%)	N/A
N/A	Gutter Lip Ht (in)	N/A	N/A	Gutter X Slope (%)	N/A
N/A	Painted X Walk1?	No	N/A	Painted X Walk2?	No
	X Walk 1 Direction	To SE		X Walk 2 Direction	To NE
N/A	X Walk 1 Width (in)	N/A	N/A	X Walk 2 Width (in)	N/A
	X Walk 1 Slope (%)	3.4		X Walk 2 Slope (%)	2.6
	X Walk 1 X Slope (%)	2.8		X Walk 2 X Slope (%)	4.9

N/A	Ramp inside XWalk1?	N/A	N/A	Ramp inside XWalk2?	N/A
	Road Slope (%)	4.4	N/A	Clear Space?	N/A
	Road X Slope (%)	4.1	N/A	Clear Space to XWalk (in)	N/A
N/A	Any Obstructions?	N/A	N/A	Storm Grate/Utility Hazard?	N/A
	Obstruction Type			Storm Grate/Utility Type	
		N/A			N/A
			Yes	Surface Condition? (G/P)	Good

**Remove & Replace Curb Ramp With Two New Directional Ramps or Equivalent.**
