## **Access Compliance Report Public Rights-of-Way** (Curb Ramps)

Intersection ID: 27847 Main Street: PARADISE RIDGE RD Cross Street: NORTH\_COMMUNITY\_HOUSE\_RD Location: NW **ADA ID: E797BD83ED25** Ramp Type: Perp Initial Pass/Fail: Fail **Overall Compliance: No** Severity Score: 13.75

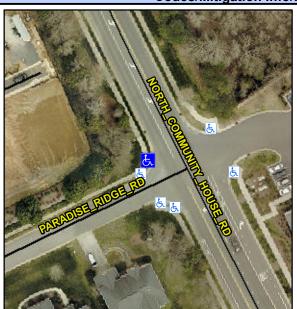
Field Measurements/Component Compliance									
Comp	liance Description	Data	Compl	liance	Description	Data			
N/A	Ramp Length (in)	99.0	No	Ramp	Slope (%)	8.8			
Yes	Ramp Width (in)	48.0	No	Ramp	XSlope (%)	4.1			
N/A	Flare Type LT	N/A	N/A	Flare	Type RT	N/A			
N/A	Flare Slope LT (%)	N/A	N/A	Flare	Slope RT (%)	N/A			
N/A	Flare Traversable LT?	N/A	N/A	Flare	Traversable RT?	N/A			
N/A	Landing Length (in)	N/A	N/A	DWS	Provided?	N/A			
N/A	Landing Width (in)	N/A	N/A	DWS	Contrast?	N/A			
N/A	Landing Slope (%)	N/A	N/A	DWS	Length (in)	N/A			
N/A	Landing X Slope (%)	N/A	N/A	DWS	Full Width?	N/A			
N/A	Landing Curb? (Y/N)	N/A	N/A	DWS	Offset (in)	N/A			
N/A	Shared Landing?	N/A							
N/A	Gutter Ponding?	N/A	N/A	Gutte	Slope (%)	N/A			
N/A	Gutter Lip Ht (in)	N/A	N/A	Gutte	X Slope (%)	N/A			
N/A	Painted X Walk1?	No	N/A	Painte	ed X Walk2?	N/A			
	X Walk 1 Direction	To NE		X Wal	k 2 Direction	N/A			
N/A	X Walk 1 Width (in)	N/A	N/A	X Wal	k 2 Width (in)	N/A

X Walk 1 Slope (%)	2.2		X Wal	k 2 Slope (%)	N/A			
	X Walk 1 X Slope (%)	2.8		X Wal	k 2 X Slope (%)	N/A			
N/A	Ramp inside XWalk1?	N/A	N/A	Ramp	inside XWalk2?	N/A			
	Road Slope (%)	N/A	N/A	Clear	Space?	N/A			
	Road X Slope (%)	N/A	N/A	Clear	Space to XWalk (in)	N/A			
N/A	Any Obstructions?	N/A	N/A	Storm	Grate/Utility Hazard?	N/A			
	Obstruction Type			Storm	Grate/Utility Type				
		N/A				N/A			
			Yes	Surfac	ce Condition? (G/P)	Good			
056A

Possible Solutions:								
Remove & Replace Entire Ramp.								
·								
Surveyor Notes:								
N/A								
PROW/ADA:								
R304.2.2, R304.5.3								
1.00 11.2, 1.00 11.010

N/A
			N/A
			N/A
PROW/ADA:			N/A
R304.2.2, R304.5.3			N/A
			N/A
			N/A
			N/A
			N/A
Total Cost:	•	\$ 1850.00
