# Access Compliance Report

## Public Rights-of-Way

### (Curb Ramps)

Intersection ID: 7806	Main Street: MANLEY_ST	Cross Street: ROZZELLES_FERRY_RD	Location: SE
ADA ID: E7A1DAA2848E	Ramp Type: Perp	Initial Pass/Fail: Fail	Overall Compliance: No
Severity Score: 21.25			
Codes/Mitigation Info/Possible Solution		Field Measurements/Component Compliance

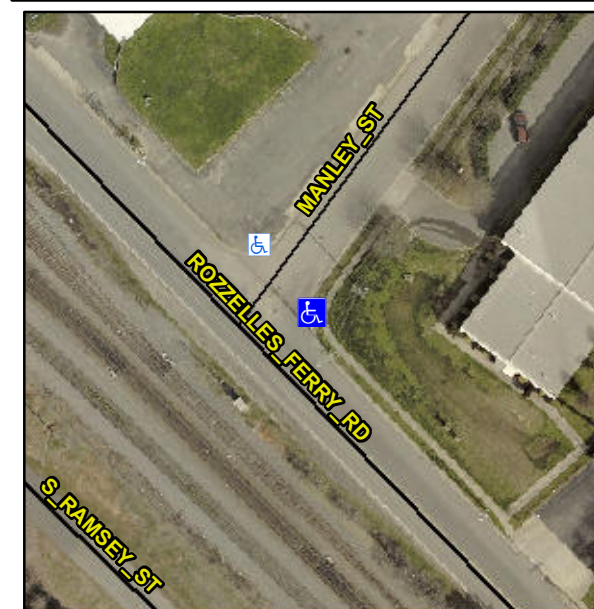
**Not Found, R304.5.1, R304.2.2**

Compliance	Description	Data	Compliance	Description	Data
N/A	Ramp Length (in)	50.0	No	Ramp Slope (%)	11.3
No	Ramp Width (in)	38.5	Yes	Ramp XSlope (%)	1.0
N/A	Flare Type LT	N/A	N/A	Flare Type RT	N/A
N/A	Flare Slope LT (%)	N/A	N/A	Flare Slope RT (%)	N/A
N/A	Flare Traversable LT?	N/A	N/A	Flare Traversable RT?	N/A
N/A	Landing Length (in)	N/A	N/A	DWS Provided?	N/A
N/A	Landing Width (in)	N/A	N/A	DWS Contrast?	N/A
N/A	Landing Slope (%)	N/A	N/A	DWS Length (in)	N/A
N/A	Landing X Slope (%)	N/A	N/A	DWS Full Width?	N/A
N/A	Landing Curb? (Y/N)	N/A	N/A	DWS Offset (in)	N/A
N/A	Shared Landing?	N/A			
N/A	Gutter Ponding?	N/A	N/A	Gutter Slope (%)	N/A
N/A	Gutter Lip Ht (in)	N/A	N/A	Gutter X Slope (%)	N/A
N/A	Painted X Walk1?	No	N/A	Painted X Walk2?	N/A
	X Walk 1 Direction	To NW		X Walk 2 Direction	N/A
N/A	X Walk 1 Width (in)	N/A	N/A	X Walk 2 Width (in)	N/A
	X Walk 1 Slope (%)	0.1		X Walk 2 Slope (%)	N/A
	X Walk 1 X Slope (%)	0.5		X Walk 2 X Slope (%)	N/A

N/A	Ramp inside XWalk1?	N/A	N/A	Ramp inside XWalk2?	N/A
	Road Slope (%)	N/A	N/A	Clear Space?	N/A
	Road X Slope (%)	N/A	N/A	Clear Space to XWalk (in)	N/A
N/A	Any Obstructions?	N/A	N/A	Storm Grate/Utility Hazard?	N/A
	Obstruction Type			Storm Grate/Utility Type	
		N/A			N/A
			Yes	Surface Condition? (G/P)	Good

Possible Solutions:

**Remove & Replace Entire Ramp.**

Total Cost: \$ 1850.00
