# Access Compliance Report

## Public Rights-of-Way

### (Curb Ramps)

| Intersection ID: 24621 | Main Street: HUGH_FOREST_RD | Cross Street: WALTHAM_LN | Location: NW |

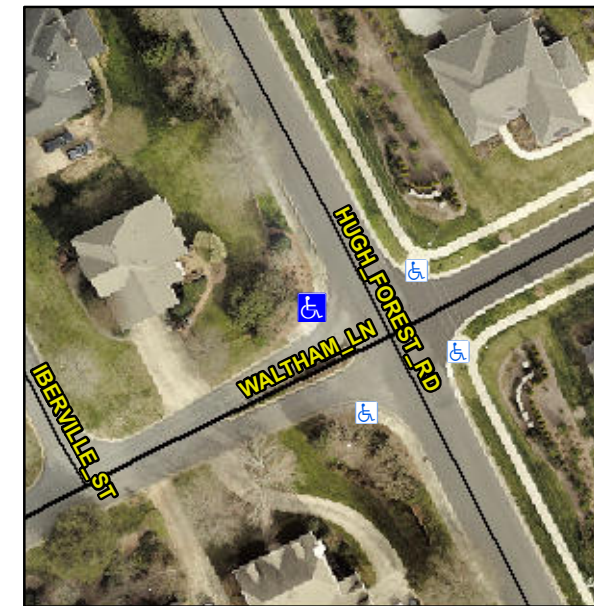
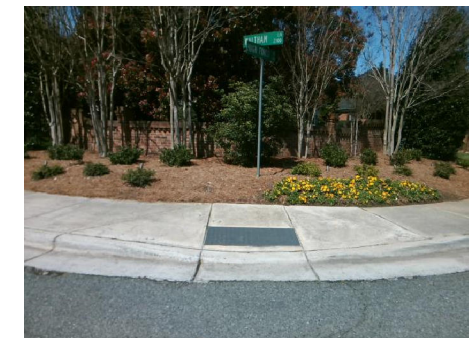
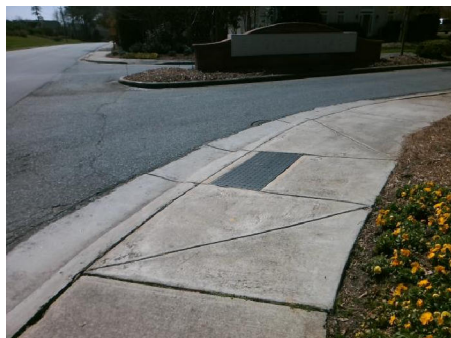
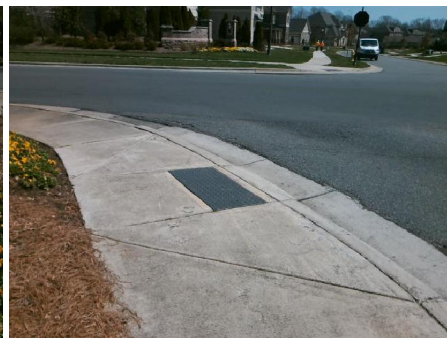
| ADA ID: E7A60F884F6B | Ramp Type: PerpDiag | Initial Pass/Fail: Fail | Overall Compliance: No |
| Severity Score: 12.5 | | | |

**Not Found, R304.2.2**

| Compliance | Description | Data | Compliance | Description | Data |
|---|---|---|---|---|---|
| N/A | Ramp Length (in) | 70.0 | No | Ramp Slope (%) | 11.1 |

**Remove & Replace Curb Ramp With Two New Directional Ramps or Equivalent.**

Total Cost: \$ 3200.00
