# Access Compliance Report

## Public Rights-of-Way

### (Curb Ramps)

Intersection ID: 6407	Main Street: CAPPS_HILL_MINE_RD	Cross Street: MILAN_RD	Location: SE
ADA ID: E7AD2D5955AA	Ramp Type: Directional1	Initial Pass/Fail: Fail	Overall Compliance: No
Codes/Mitigation Info/Possible Solution		Field Measurements/Component Compliance	
Severity Score: 8.75

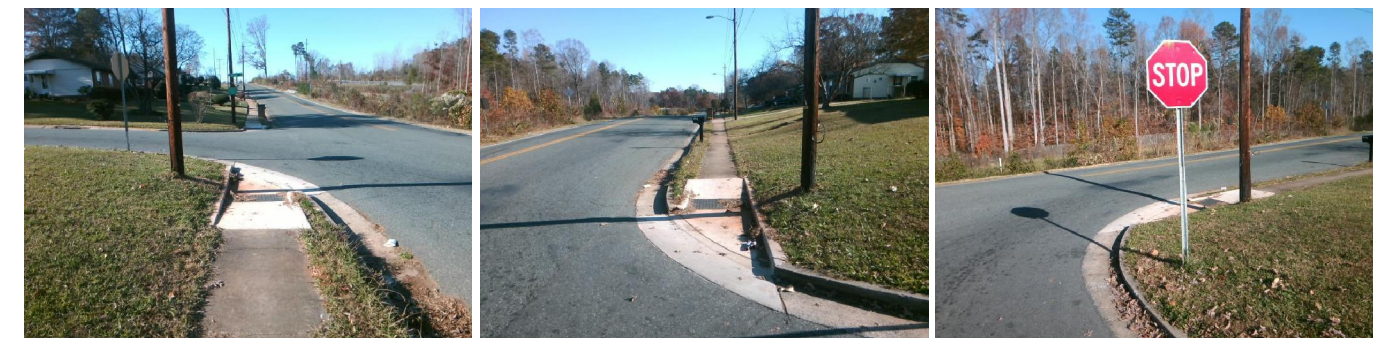
Possible Solutions:				
	Remove & Replace Entire Ramp.				
	Surveyor Notes:				
	N/A				
	PROW/ADA:				
	R304.5.1				
	Street 1 Name	MILAN RD			
	Stop Condition-Street 1	StopSign			
	Street 2 Name	N/A			
	Stop Condition-Street 2	N/A			
Total Cost:		\$	1600.00		
		Compliance	Description	Data	Compliance Description Data
		N/A	Ramp Length (in)	62.0	N/A Grade Break? N/A
		No	Ramp Width (in)	47.0	N/A Grade Break Slope (%) 0.0
		Yes	Ramp Slope (%)	5.7	N/A Grade Break XSlope (%) 0.0
		Yes	Ramp XSlope (%)	0.5	
		N/A	Flare Type LT	N/A	N/A Flare Type RT N/A
		N/A	Flare Slope LT (%)	N/A	N/A Flare Slope RT (%) 0.0
		N/A	Flare Traversable LT?	N/A	N/A Flare Traversable RT? N/A
		N/A	Landing Length (in)	0.0	N/A DWS Provided? N/A
		N/A	Landing Width (in)	0.0	N/A DWS Contrast? N/A
		N/A	Landing Slope (%)	0.0	N/A DWS Length (in) N/A
		N/A	Landing X Slope (%)	0.0	N/A DWS Full Width? N/A
		N/A	Landing Curb? (Y/N)	N/A	N/A DWS Offset LT (in) N/A

N/A	Shared Landing?	N/A	N/A DWS Offset RT (in) N/A
		N/A	Gutter Ponding?	0.0	N/A Gutter Slope (%) N/A
		N/A	Gutter Lip Ht (in)	0.0	N/A Gutter X Slope (%) N/A
		N/A	Painted X Walk1?	No	Road Slope (%) 1.2
			X Walk 1 Direction	To NW	Road X Slope (%) 5.8
			X Walk 1 Width (in)	N/A	Clear Space? N/A
			X Walk 1 Slope (%)	1.2	N/A Clear Space to XWalk (in) N/A
			X Walk 1 X Slope (%)	5.8	N/A Storm Grate/Utility Hazard? N/A
		N/A	Ramp inside XWalk1?	N/A	Storm Grate/Utility Type
		N/A	Any Obstructions?	N/A	N/A
			Obstruction Type		Yes Surface Condition? (G/P) Good
				N/A	N/A Curb Slope (%) 18.9
