# Access Compliance Report

## Public Rights-of-Way

### (Curb Ramps)

Intersection ID: N/A	Main Street: PAINTED_TRILLIUM_CT	Cross Street: LONGSPUR_DR	Location: SW
ADA ID: E7B12D2BC803	Ramp Type: BlendTrans2	Initial Pass/Fail: Fail	Overall Compliance: No
Severity Score: 12.5			
Codes/Mitigation Info/Possible Solution		Field Measurements/Component Compliance

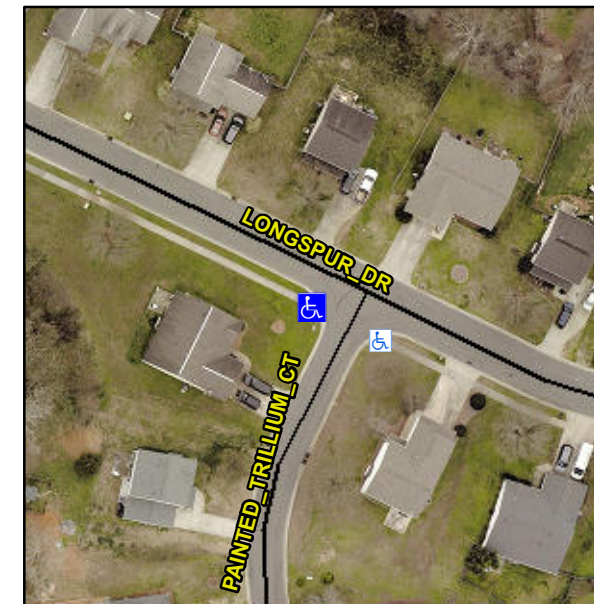
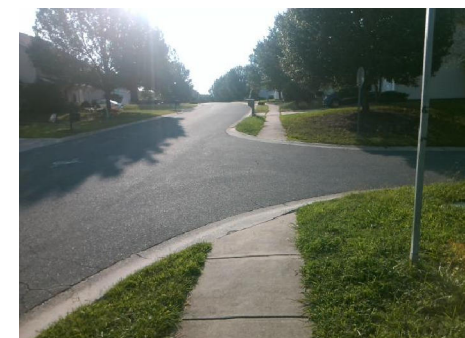
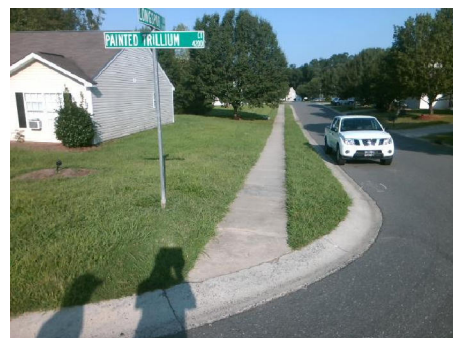
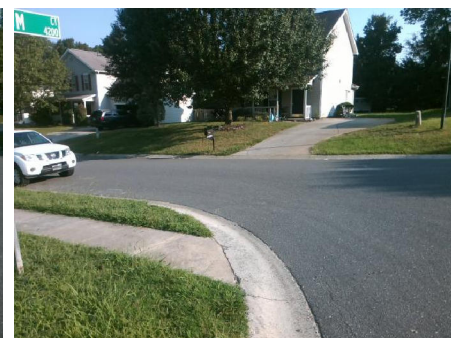
Compliance	Description	Data	Compliance	Description	Data
N/A	Ramp Length (in)	47.0	Yes	BlendTrans Slope (%)	3.2
Yes	Ramp Width (in)	48.0	No	BlendTrans XSlope (%)	6.1
N/A	Flare Type LT	N/A	N/A	Flare Type RT	N/A
N/A	Flare Slope LT (%)	N/A	N/A	Flare Slope RT (%)	N/A
N/A	Flare Traversable LT?	N/A	N/A	Flare Traversable RT?	N/A
N/A	Landing Length (in)	N/A	N/A	DWS Provided?	N/A
N/A	Landing Width (in)	N/A	N/A	DWS Contrast?	N/A
N/A	Landing Slope (%)	N/A	N/A	DWS Length (in)	N/A
N/A	Landing X Slope (%)	N/A	N/A	DWS Full Width?	N/A
N/A	Landing Curb? (Y/N)	N/A	N/A	DWS Offset (in)	N/A
N/A	Shared Landing?	N/A			
N/A	Gutter Ponding?	N/A	N/A	Gutter Slope (%)	N/A
N/A	Gutter Lip Ht (in)	N/A	N/A	Gutter X Slope (%)	N/A
N/A	Painted X Walk1?	No	N/A	Painted X Walk2?	No
	X Walk 1 Direction	To SE		X Walk 2 Direction	To NE
	X Walk 1 Width (in)	N/A		X Walk 2 Width (in)	N/A
	X Walk 1 Slope (%)	5.1		X Walk 2 Slope (%)	0.8
	X Walk 1 X Slope (%)	1.2		X Walk 2 X Slope (%)	7.0

N/A	Ramp inside XWalk1?	N/A	N/A	Ramp inside XWalk2?	N/A
	Road Slope (%)	4.1		Clear Space?	N/A
	Road X Slope (%)	6.8	N/A	Clear Space to XWalk (in)	N/A
N/A	Any Obstructions?	N/A	N/A	Storm Grate/Utility Hazard?	N/A
	Obstruction Type			Storm Grate/Utility Type	
		N/A			N/A
			Yes	Surface Condition? (G/P)	Good
			N/A	Curb Slope (%)	1.0

**Remove & Replace Curb Ramp With Two New Directional Ramps or Equivalent.**

**R304.5.3**
