Access Compliance Report Public Rights-of-Way (Curb Ramps)

Intersection ID: 4985	Main St		Cross	Street		Location:	w		
	Main Street: OLD_STATESVILLE_RD			Cross Street: APACHE_AV					
ADA ID: E7C5BC1DFF21 Ramp Type: Perp			Initial	Initial Pass/Fail: Fail Overall Compliance: No				o Severity Score:	21.25
Codes/Mitigation Info/Possible Solution				Field Measurements/Component Compliance					
	VII MI	Possible Solutions:		Compliance Description			Data Compliance Description		
	1/20/14	Remove & Replace Entire Ram) .	N/A	Ramp Length (in)	60.0	No	Ramp Slope (%)	10.7
D D	1 7 1	-		No	Ramp Width (in)	40.0	Yes	Ramp XSlope (%)	0.6
NARABY REALINE				N/A	Flare Type LT	N/A	N/A	Flare Type RT	N/A
Apar	1118	1		N/A	Flare Slope LT (%)	N/A	N/A	Flare Slope RT (%)	N/A
ALL ALL		6		N/A	Flare Traversable LT?	N/A	N/A	Flare Traversable RT?	N/A
A A		9		N/A	Landing Length (in)	N/A	N/A	DWS Provided?	N/A
	103	Surveyor Notes:		N/A	Landing Width (in)	N/A	N/A	DWS Contrast?	N/A
the second s		N/A		N/A	Landing Slope (%)	N/A	N/A	DWS Length (in)	N/A

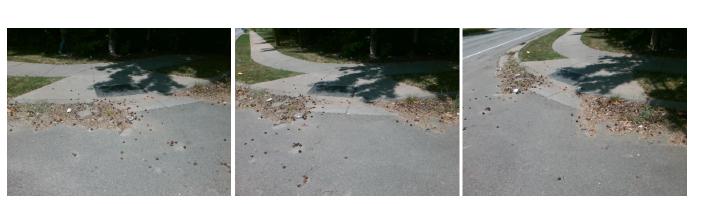
XALLER	÷		N/A	Landing X Slope (%)	N/A	N/A	DWS Full Width?	N/A
3	N. State	N		N/A	Landing Curb? (Y/N)	N/A	N/A	DWS Offset (in)	N/A
	ALL +			N/A	Shared Landing?	N/A			
LA SATE AN IN	and the second	PROW/ADA:		N/A	Gutter Ponding?	Yes	N/A	Gutter Slope (%)	N/A
2 3 4 16 / / / / / /		Not Found, R304.5.1, R304.2.2		N/A	Gutter Lip Ht (in)	N/A	N/A	Gutter X Slope (%)	N/A
		· ·		N/A	Painted X Walk1?	No	N/A	Painted X Walk2?	N/A
	1000				X Walk 1 Direction	To NE		X Walk 2 Direction	N/A
X Plat 11 X			N/A	X Walk 1 Width (in)	N/A	N/A	X Walk 2 Width (in)	N/A	
Street 1 Name	APACHE AV				X Walk 1 Slope (%)	2.4		X Walk 2 Slope (%)	N/A
Stop Condition-Street 2	YieldSign				X Walk 1 X Slope (%)	0.7		X Walk 2 X Slope (%)	N/A
Street 2 Name	N/A			N/A	Ramp inside XWalk1?	N/A	N/A	Ramp inside XWalk2?	N/A
Stop Condition-Street 1	N/A				Road Slope (%)	N/A	N/A	Clear Space?	N/A
					Road X Slope (%)	N/A	N/A	Clear Space to XWalk (in)	N/A

N/A	Any Obstructions?	N/A	N/A	Storm Grate/Utility Hazard?	N/A
		Total Cost: \$	1850.00		Obstruction Type			Storm Grate/Utility Type	
						N/A			N/A
