Intersection ID: 16694	Main Street: BOSTON_AV	Cross Street: ROSEHILL_DR	Location:	NE
ADA ID: E7C9A6DB5427	Ramp Type: PerpDiag	Initial Pass/Fail: Fail	Overall Compliance: No	Severity Score: 13.75

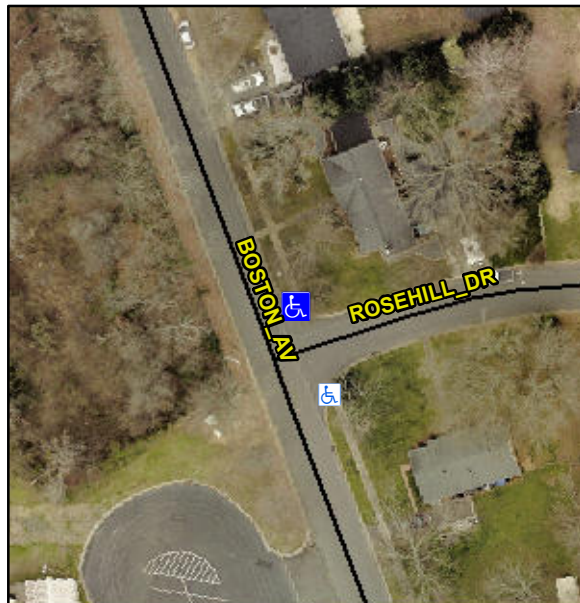
Not Found, R304.2.2, R304.5.3

Compliance	Description	Data	Compliance	Description	Data
N/A	Ramp Length (in)	25.0	No	Ramp Slope (%)	9.7
Yes	Ramp Width (in)	48.0	No	Ramp XSlope (%)	4.3
N/A	Flare Type LT	N/A	N/A	Flare Type RT	N/A
N/A	Flare Slope LT (%)	N/A	N/A	Flare Slope RT (%)	N/A
N/A	Flare Traversable LT?	N/A	N/A	Flare Traversable RT?	N/A
N/A	Landing Length (in)	N/A	N/A	DWS Provided?	N/A
N/A	Landing Width (in)	N/A	N/A	DWS Contrast?	N/A
N/A	Landing Slope (%)	N/A	N/A	DWS Length (in)	N/A
N/A	Landing X Slope (%)	N/A	N/A	DWS Full Width?	N/A
N/A	Landing Curb? (Y/N)	N/A	N/A	DWS Offset (in)	N/A
N/A	Shared Landing?	N/A			
N/A	Gutter Ponding?	N/A	N/A	Gutter Slope (%)	N/A
N/A	Gutter Lip Ht (in)	N/A	N/A	Gutter X Slope (%)	N/A
N/A	Painted X Walk1?	No	N/A	Painted X Walk2?	No
	X Walk 1 Direction	To W		X Walk 2 Direction	To SE
N/A	X Walk 1 Width (in)	N/A	N/A	X Walk 2 Width (in)	N/A
	X Walk 1 Slope (%)	3.6		X Walk 2 Slope (%)	5.6
	X Walk 1 X Slope (%)	5.8		X Walk 2 X Slope (%)	1.8

N/A	Ramp inside XWalk1?	N/A	N/A	Ramp inside XWalk2?	N/A
	Road Slope (%)	2.4	N/A	Clear Space?	N/A
	Road X Slope (%)	4.2	N/A	Clear Space to XWalk (in)	N/A
N/A	Any Obstructions?	N/A	N/A	Storm Grate/Utility Hazard?	N/A
	Obstruction Type			Storm Grate/Utility Type	
		N/A			N/A
			Yes	Surface Condition? (G/P)	Good

Remove & Replace Curb Ramp With Two New Directional Ramps or Equivalent.

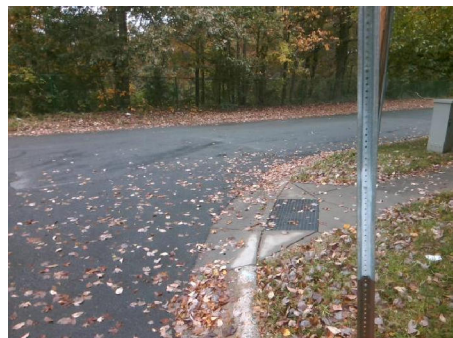
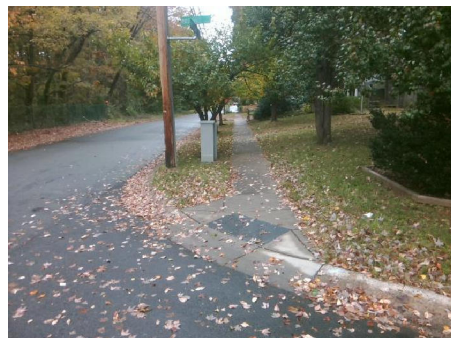
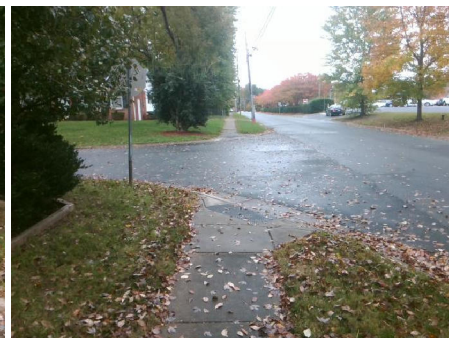
Street 1 Name	BOSTON AV
Stop Condition-Street 2	None
Street 2 Name	ROSEHILL DR
Stop Condition-Street 1	StopSign
