Access Compliance Report

Public Rights-of-Way

(Curb Ramps)

Intersection ID: 31765	Main Street: FIRST_RUN_CT	Cross Street: PINYON_PINE_LN	Location:	N
ADA ID: E7D8B2BAAB5D	Ramp Type: Combination2	Initial Pass/Fail: Fail	Overall Compliance: No	Severity Score: 46.25
Codes/Mitigation Info/Possible Solution		Field Measurements/Component Compliance

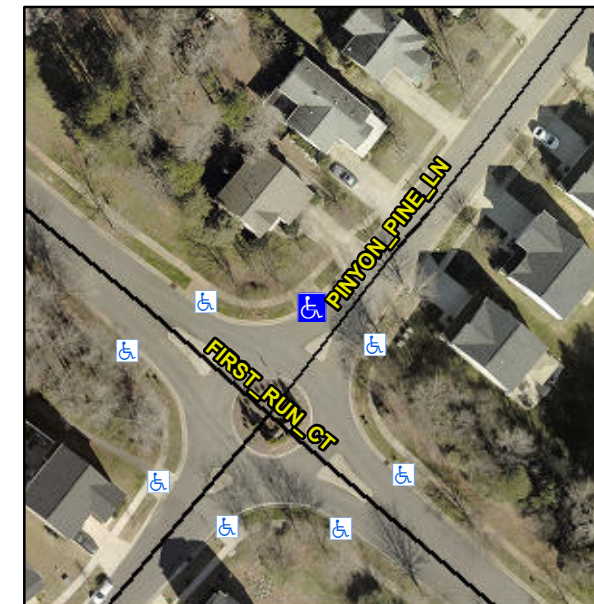
LT RP < 5%

R304.5.3, R304.3.2

Compliance	Description	Data	Compliance	Description	Data
N/A	Ramp Length LT (in)	57.5	N/A	Ramp Length RT (in)	57.5
N/A	Ramp Width LT (in)	47.5	Yes	Ramp Width RT (in)	48.0
N/A	Ramp Slope LT (%)	4.2	No	Ramp Slope RT (%)	10.6
N/A	Ramp XSlope LT (%)	1.8	Yes	Ramp XSlope RT (%)	1.9
N/A	Ramp Length (in)	82.5	Yes	Ramp Slope (%)	5.2
Yes	Ramp Width (in)	48.0	No	Ramp XSlope (%)	7.5
N/A	Flare Type LT	N/A	N/A	Flare Type RT	N/A
N/A	Flare Slope LT (%)	N/A	N/A	Flare Slope RT (%)	N/A
N/A	Flare Traversable LT?	N/A	N/A	Flare Traversable RT?	N/A
N/A	Landing Length (in)	N/A	N/A	DWS Provided?	N/A
N/A	Landing Width (in)	N/A	N/A	DWS Contrast?	N/A
N/A	Landing Slope (%)	N/A	N/A	DWS Length (in)	N/A
N/A	Landing X Slope (%)	N/A	N/A	DWS Full Width?	N/A
N/A	Landing Curb? (Y/N)	N/A	N/A	DWS Offset (in)	N/A
N/A	Shared Landing?	N/A			
N/A	Gutter Ponding?	N/A	N/A	Gutter Slope (%)	N/A
N/A	Gutter Lip Ht (in)	N/A	N/A	Gutter X Slope (%)	N/A
N/A	Painted X Walk1?	No	N/A	Painted X Walk2?	N/A

X Walk 1 Direction	To SE		X Walk 2 Direction	N/A
	X Walk 1 Width (in)	N/A		X Walk 2 Width (in)	N/A
	X Walk 1 Slope (%)	2.7		X Walk 2 Slope (%)	N/A
	X Walk 1 X Slope (%)	7.5		X Walk 2 X Slope (%)	N/A
N/A	Ramp inside XWalk1?	N/A	N/A	Ramp inside XWalk2?	N/A
	Road Slope (%)	N/A		Clear Space?	N/A
	Road X Slope (%)	N/A	N/A	Clear Space to XWalk (in)	N/A
			N/A	Any Obstruction?	N/A
				Obstruction Type	N/A
			N/A	Storm Grate/Utility Hazard?	N/A
				Storm Grate/Utility Type	N/A
			Yes	Surface Condition? (G/P)	Good
				Curb Slope (%)	4.2

Possible Solutions:

Remove & Replace Entire Ramp.
