Access Compliance Report

Public Rights-of-Way

(Curb Ramps)

Intersection ID: 15520	Main Street: FLORAL_AV	Cross Street: LATTIMORE_ST	Location: W
ADA ID: E7DB84B1748A	Ramp Type: Directional1	Initial Pass/Fail: Fail	Overall Compliance: No
Codes/Mitigation Info/Possible Solution		Field Measurements/Component Compliance	
Severity Score: 13.75

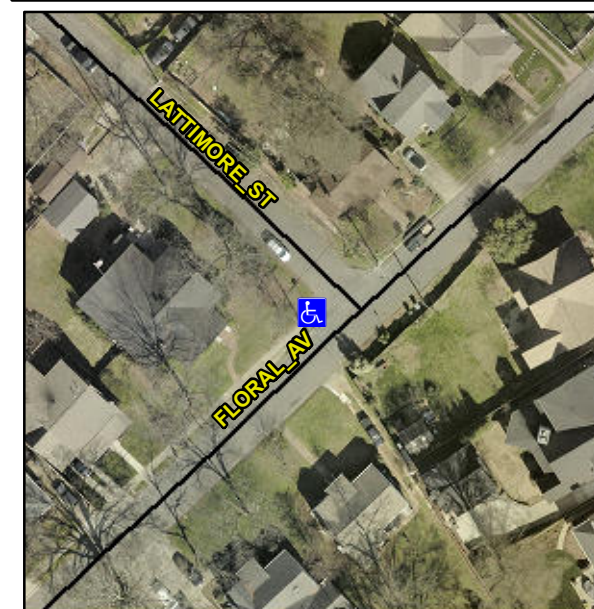
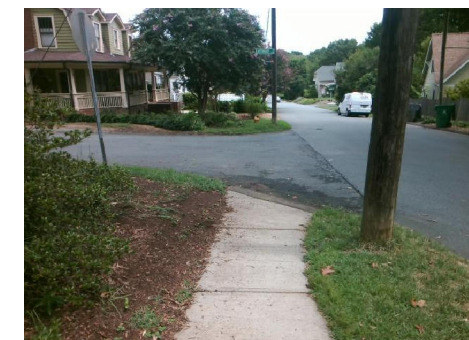
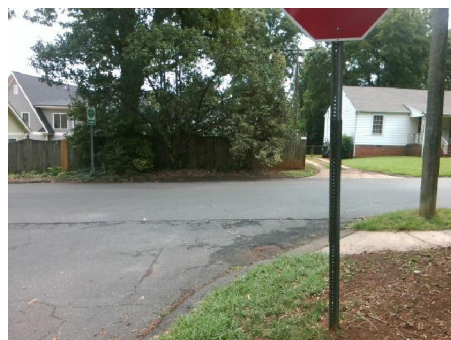
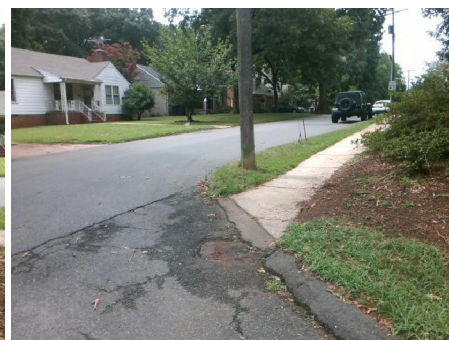
Compliance	Description	Data	Compliance	Description	Data
N/A	Ramp Length (in)	32.0	N/A	Grade Break?	N/A
Yes	Ramp Width (in)	48.0	N/A	Grade Break Slope (%)	0.0
No	Ramp Slope (%)	9.3	N/A	Grade Break XSlope (%)	0.0
No	Ramp XSlope (%)	4.5			
N/A	Flare Type LT	N/A	N/A	Flare Type RT	N/A
N/A	Flare Slope LT (%)	N/A	N/A	Flare Slope RT (%)	0.0
N/A	Flare Traversable LT?	N/A	N/A	Flare Traversable RT?	N/A
N/A	Landing Length (in)	0.0	N/A	DWS Provided?	N/A
N/A	Landing Width (in)	0.0	N/A	DWS Contrast?	N/A
N/A	Landing Slope (%)	0.0	N/A	DWS Length (in)	N/A
N/A	Landing X Slope (%)	0.0	N/A	DWS Full Width?	N/A
N/A	Landing Curb? (Y/N)	N/A	N/A	DWS Offset LT (in)	N/A
N/A	Shared Landing?	N/A	N/A	DWS Offset RT (in)	N/A
N/A	Gutter Ponding?	0.0	N/A	Gutter Slope (%)	N/A
N/A	Gutter Lip Ht (in)	0.0	N/A	Gutter X Slope (%)	N/A
N/A	Painted X Walk1?	No		Road Slope (%)	2.5
	X Walk 1 Direction	To NE		Road X Slope (%)	0.0
	X Walk 1 Width (in)	N/A		Clear Space?	N/A

X Walk 1 Slope (%)	2.5	N/A	Clear Space to XWalk (in)	N/A
	X Walk 1 X Slope (%)	0.0	N/A	Storm Grate/Utility Hazard?	N/A
N/A	Ramp inside XWalk1?	N/A		Storm Grate/Utility Type	
N/A	Any Obstructions?	N/A			N/A
	Obstruction Type		Yes	Surface Condition? (G/P)	Good
			N/A	Curb Slope (%)	7.3

Possible Solutions:

Remove & Replace Entire Ramp.
