Access Compliance Report

Public Rights-of-Way

(Curb Ramps)

Intersection ID: 52920	Main Street: RIVERGATE_VIEW_DR	Cross Street: WALKER_BRANCH_DR	Location: NE
ADA ID: E7DC3E51D22E	Ramp Type: PerpDiag	Initial Pass/Fail: Fail	Overall Compliance: No
			Severity Score: 46.25

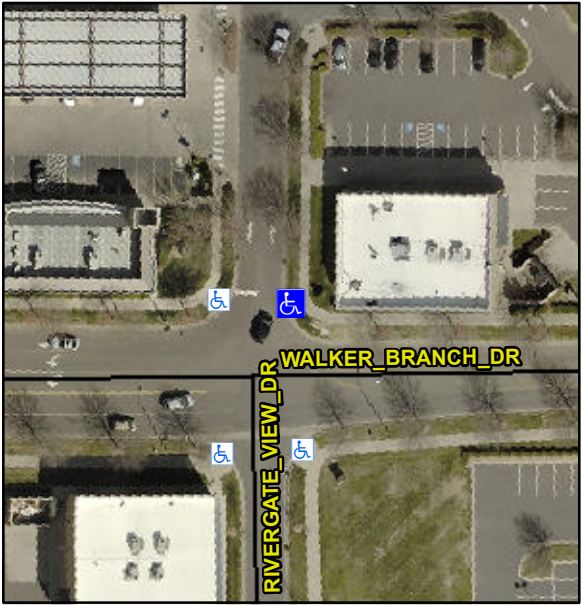
Surveyor Notes:		No	Ramp Length (in)	87.0
	N/A		No	Ramp Width (in)	46.0

Possible Solutions:		Compliance	Description	Data
	Remove & Replace Curb Ramp With Two New Directional Ramps or Equivalent.		Compliance	Description	Data

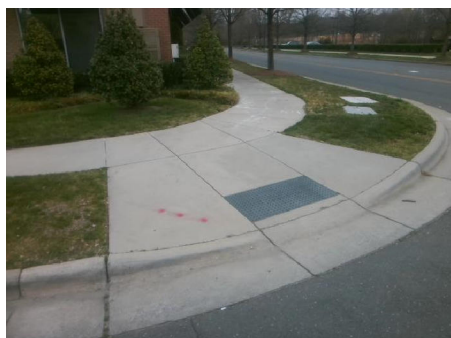
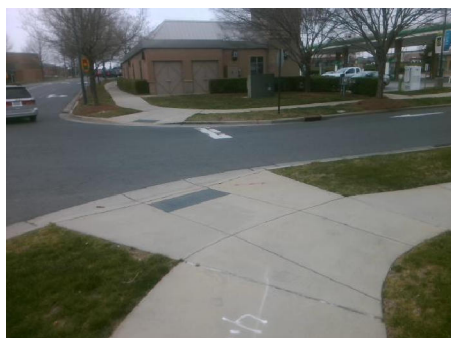
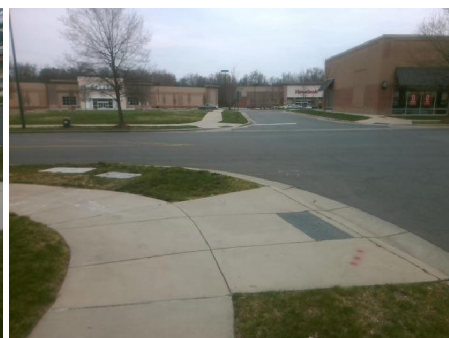
PROW/ADA:		N/A	Flare Type LT	N/A
	Not Found, R304.5.1, R304.2.2, R304.5.3		N/A	Flare Slope LT (%)	N/A

Total Cost: \$ 3200.00
