Intersection ID: 48166	Main Street: NORTHLAKE_MALL_DR	Cross Street: NORTHLAKE_CENTRE_PY	Location:	SW
ADA ID: E7DCDC EE BF72	Ramp Type: Perp	Initial Pass/Fail: Fail	Overall Compliance: No	Severity Score: 13.75

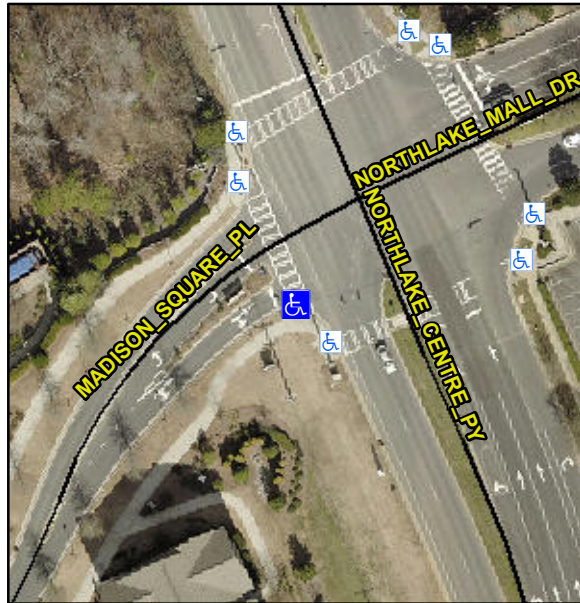
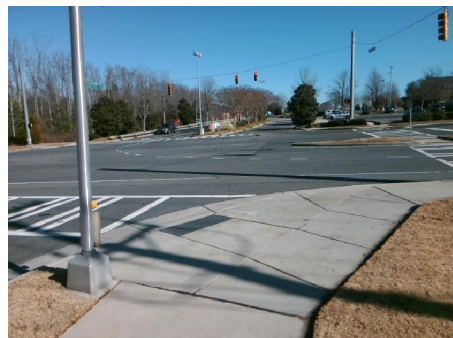
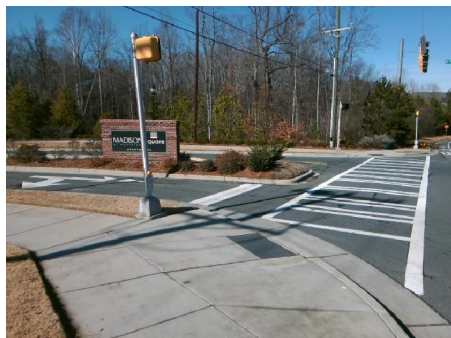
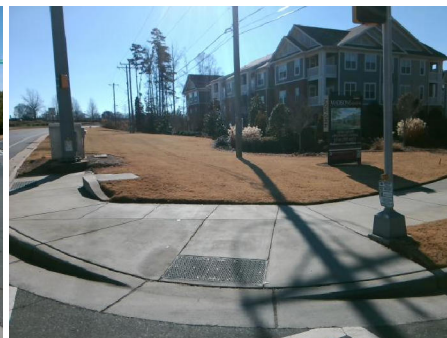
**Not Found, R304.2.2, R304.5.3**

Compliance	Description	Data	Compliance	Description	Data
N/A	Ramp Length (in)	85.0	No	Ramp Slope (%)	8.4
Yes	Ramp Width (in)	48.0	No	Ramp XSlope (%)	3.1
N/A	Flare Type LT	N/A	N/A	Flare Type RT	N/A
N/A	Flare Slope LT (%)	N/A	N/A	Flare Slope RT (%)	N/A
N/A	Flare Traversable LT?	N/A	N/A	Flare Traversable RT?	N/A
N/A	Landing Length (in)	N/A	N/A	DWS Provided?	N/A
N/A	Landing Width (in)	N/A	N/A	DWS Contrast?	N/A
N/A	Landing Slope (%)	N/A	N/A	DWS Length (in)	N/A
N/A	Landing X Slope (%)	N/A	N/A	DWS Full Width?	N/A
N/A	Landing Curb? (Y/N)	N/A	N/A	DWS Offset (in)	N/A
N/A	Shared Landing?	N/A			
N/A	Gutter Ponding?	N/A	N/A	Gutter Slope (%)	N/A
N/A	Gutter Lip Ht (in)	N/A	N/A	Gutter X Slope (%)	N/A
N/A	Painted X Walk1?	Yes	N/A	Painted X Walk2?	N/A
	X Walk 1 Direction	To NW		X Walk 2 Direction	N/A
N/A	X Walk 1 Width (in)	115.0	N/A	X Walk 2 Width (in)	N/A
	X Walk 1 Slope (%)	3.4		X Walk 2 Slope (%)	N/A
	X Walk 1 X Slope (%)	2.0		X Walk 2 X Slope (%)	N/A

N/A	Ramp inside XWalk1?	Yes	N/A	Ramp inside XWalk2?	N/A
	Road Slope (%)	N/A	N/A	Clear Space?	N/A
	Road X Slope (%)	N/A	N/A	Clear Space to XWalk (in)	N/A
N/A	Any Obstructions?	N/A	N/A	Storm Grate/Utility Hazard?	N/A
	Obstruction Type			Storm Grate/Utility Type	
		N/A			N/A
			Yes	Surface Condition? (G/P)	Good

### Remove & Replace Entire Ramp.

Total Cost: \$ 1850.00
