## Access Compliance Report Public Rights-of-Way (Curb Ramps)

Intersection ID: 17072 Main Street: IDLEWILD\_RD Cross Street: DION\_AV Location: S

ADA ID: E7DE7DA90DF5 Ramp Type: PerpDiag Initial Pass/Fail: Fail Overall Compliance: No Severity Score: 25

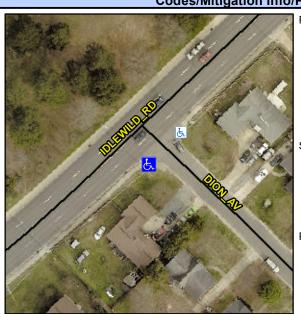
Not Found, R304.2.2

Compliance Description			Data	Compliance Description		Data
ĺ	N/A	Ramp Length (in)	68.0	No	Ramp Slope (%)	13.6
•	Yes	Ramp Width (in)	48.0	Yes	Ramp XSlope (%)	2.0
ı	N/A	Flare Type LT	N/A	N/A	Flare Type RT	N/A
ı	N/A	Flare Slope LT (%)	N/A	N/A	Flare Slope RT (%)	N/A
ı	N/A	Flare Traversable LT?	N/A	N/A	Flare Traversable RT?	N/A

Remove & Replace Curb Ramp With
Two New Directional Ramps or
Equivalent.
