# Access Compliance Report

## Public Rights-of-Way

### (Curb Ramps)

Intersection ID: 4733	Main Street: KENDALE_CT	Cross Street: TRINITY_RD	Location: W
ADA ID: E7E024338E9F	Ramp Type: Perp	Initial Pass/Fail: Fail	Overall Compliance: No
		Severity Score: 8.75

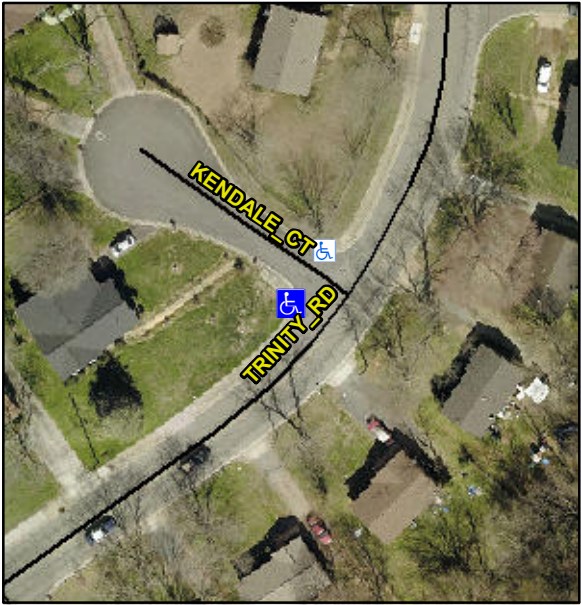
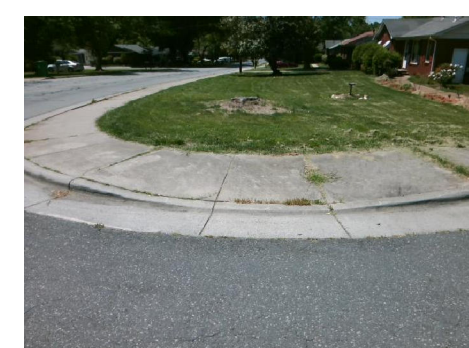
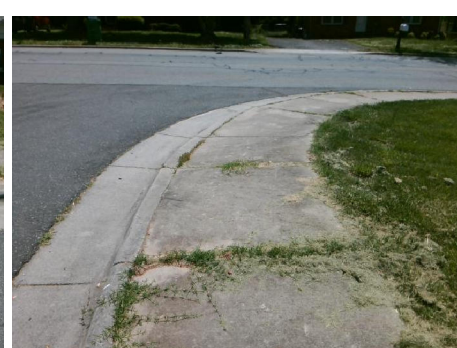
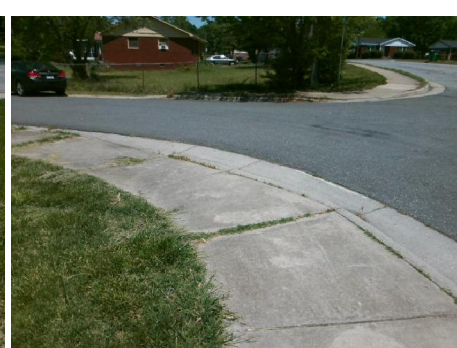
Possible Solutions:		<b>Compliance</b>	<b>Description</b>	<b>Data</b>
	<b>Remove &amp; Replace Entire Ramp.</b>		<b>Yes</b>	Ramp Slope (%)	8.1
			<b>No</b>	Ramp Width (in)	0.4
			<b>N/A</b>	Flare Type LT	N/A
			<b>N/A</b>	Flare Slope LT (%)	N/A
			<b>N/A</b>	Flare Traversable LT?	N/A
			<b>N/A</b>	Landing Length (in)	N/A
			<b>N/A</b>	Landing Width (in)	N/A
			<b>N/A</b>	Landing Slope (%)	N/A
			<b>N/A</b>	Landing X Slope (%)	N/A
<p>Surveyor Notes:</p> <p><b>N/A</b></p> <p>PROW/ADA:</p> <p><b>R304.5.1</b></p>			<b>N/A</b>	Flare Type RT	N/A
			<b>N/A</b>	Flare Slope RT (%)	N/A
			<b>N/A</b>	Flare Traversable RT?	N/A
			<b>N/A</b>	DWS Provided?	N/A
			<b>N/A</b>	DWS Contrast?	N/A
			<b>N/A</b>	DWS Length (in)	N/A
			<b>N/A</b>	DWS Full Width?	N/A
			<b>N/A</b>	DWS Offset (in)	N/A
			<b>N/A</b>	Shared Landing?	N/A
			<b>N/A</b>	Gutter Ponding?	N/A

<b>N/A</b>	Gutter Lip Ht (in)	N/A
			<b>N/A</b>	Painted X Walk1?	N/A
			<b>No</b>	Painted X Walk2?	N/A
			<b>To NE</b>	X Walk 2 Direction	N/A
			<b>N/A</b>	X Walk 2 Width (in)	N/A
			<b>2.0</b>	X Walk 2 Slope (%)	N/A
			<b>0.6</b>	X Walk 2 X Slope (%)	N/A
			<b>N/A</b>	Ramp inside XWalk2?	N/A
			<b>N/A</b>	Clear Space?	N/A
			<b>N/A</b>	Clear Space to XWalk (in)	N/A
			<b>N/A</b>	Storm Grate/Utility Hazard?	N/A
			<b>N/A</b>	Storm Grate/Utility Type	N/A
			<b>N/A</b>		N/A
			<b>Yes</b>	Surface Condition? (G/P)	Good
Total Cost:		\$ 1850.00
