## Access Compliance Report Public Rights-of-Way (Curb Ramps)

Intersection ID: 11663 Main Street: PARKWOOD\_AV Cross Street: PARSON\_ST Location: NW

ADA ID: E7F2ABAFD32E Ramp Type: Perp Initial Pass/Fail: Fail Overall Compliance: No Severity Score: 33.75

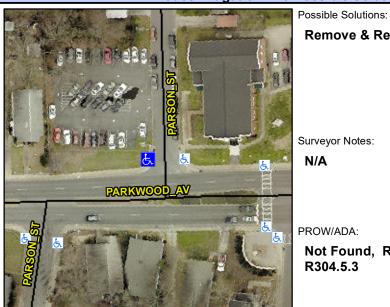
Field Measurements/Component Compliance							
Comp	liance Description	Data	Comp	liance Description	Data		
N/A	Ramp Length (in)	55.0	No	Ramp Slope (%)	8.5		
No	Ramp Width (in)	47.0	No	No Ramp XSlope (%)			
N/A	Flare Type LT	N/A	N/A	N/A Flare Type RT			
N/A	Flare Slope LT (%)	N/A	N/A	Flare Slope RT (%)	N/A		
N/A	Flare Traversable LT?	N/A	N/A	Flare Traversable RT?	N/A		
N/A	Landing Length (in)	N/A	N/A	DWS Provided?	N/A		
N/A	Landing Width (in)	N/A	N/A	DWS Contrast?	N/A		
N/A	Landing Slope (%)	N/A	N/A	DWS Length (in)	N/A		
N/A	Landing X Slope (%)	N/A	N/A	DWS Full Width?	N/A		
N/A	Landing Curb? (Y/N)	N/A	N/A	DWS Offset (in)	N/A		
N/A	Shared Landing?	N/A					
N/A	Gutter Ponding?	N/A	N/A	Gutter Slope (%)	N/A		
N/A	Gutter Lip Ht (in)	0.5	N/A	Gutter X Slope (%)	N/A		
N/A	Painted X Walk1?	No	N/A	N/A Painted X Walk2?			
	X Walk 1 Direction	To E		X Walk 2 Direction			
N/A	X Walk 1 Width (in)	N/A	N/A	X Walk 2 Width (in)	N/A

X Walk 1 Slope (%)	4.0		X Walk 2 Slope (%)			
	X Walk 1 X Slope (%)	5.9		X Walk 2 X Slope (%)	N/A		
N/A	Ramp inside XWalk1?	N/A	N/A	Ramp inside XWalk2?	N/A		
	Road Slope (%)	N/A	N/A	N/A Clear Space?			
	Road X Slope (%)	N/A	N/A	Clear Space to XWalk (in)	N/A		
N/A	Any Obstructions?	N/A	N/A	Storm Grate/Utility Hazard?	N/A		
	Obstruction Type			Storm Grate/Utility Type			
		N/A			N/A		
			Yes	Surface Condition? (G/P)	Good

1 OSSIDIC OCIULIOTIS.				
Remove & Replace Entire Ramp.				
Surveyor Notes:				
N/A				
1071				
PROW/ADA:				
Not Found, R304.5.1, R304.2.2,				
R304.5.3
