Access Compliance Report

Public Rights-of-Way

(Curb Ramps)

Intersection ID: 14311	Main Street: BERKELEY_AV	Cross Street: CARLTON_AV	Location: SE
ADA ID: E7FEBBC5E660	Ramp Type: Directional1	Initial Pass/Fail: Fail	Overall Compliance: No
Codes/Mitigation Info/Possible Solution		Field Measurements/Component Compliance	
Severity Score: 13.75

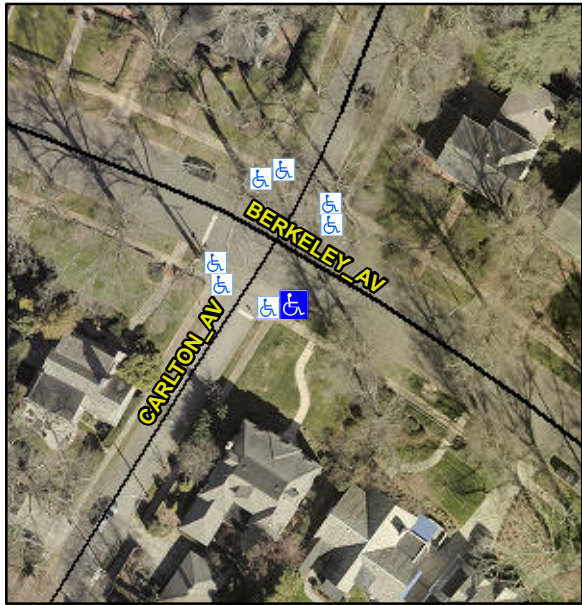
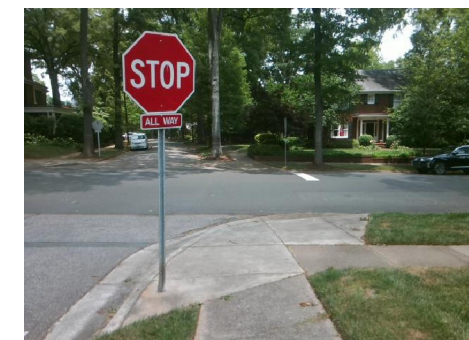
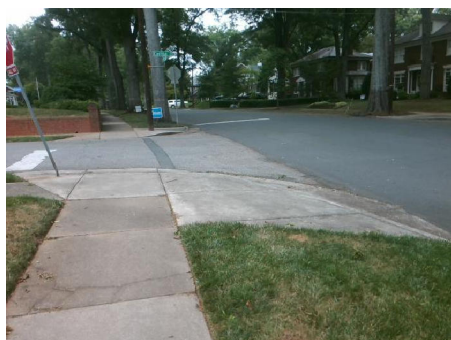
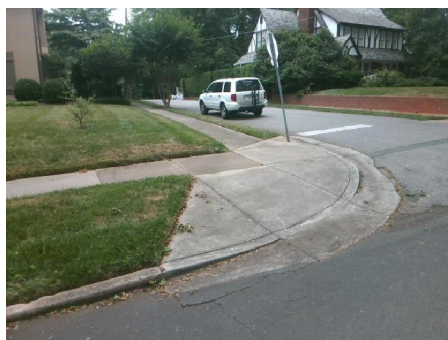
Compliance	Description	Data	Compliance	Description	Data
N/A	Ramp Length (in)	82.0	N/A	Grade Break?	N/A
Yes	Ramp Width (in)	61.0	N/A	Grade Break Slope (%)	0.0
No	Ramp Slope (%)	9.4	N/A	Grade Break XSlope (%)	0.0
No	Ramp XSlope (%)	2.6			
N/A	Flare Type LT	N/A	N/A	Flare Type RT	N/A
N/A	Flare Slope LT (%)	N/A	N/A	Flare Slope RT (%)	0.0
N/A	Flare Traversable LT?	N/A	N/A	Flare Traversable RT?	N/A
N/A	Landing Length (in)	0.0	N/A	DWS Provided?	N/A
N/A	Landing Width (in)	0.0	N/A	DWS Contrast?	N/A
N/A	Landing Slope (%)	0.0	N/A	DWS Length (in)	N/A
N/A	Landing X Slope (%)	0.0	N/A	DWS Full Width?	N/A
N/A	Landing Curb? (Y/N)	N/A	N/A	DWS Offset LT (in)	N/A
N/A	Shared Landing?	N/A	N/A	DWS Offset RT (in)	N/A
N/A	Gutter Ponding?	0.0	N/A	Gutter Slope (%)	N/A
N/A	Gutter Lip Ht (in)	0.0	N/A	Gutter X Slope (%)	N/A
N/A	Painted X Walk1?	No			
	X Walk 1 Direction	To NE			
	X Walk 1 Width (in)	N/A			
	X Walk 1 Slope (%)	3.3	N/A	Clear Space?	N/A

X Walk 1 X Slope (%)	3.2	N/A	Clear Space to XWalk (in)	N/A
N/A	Ramp inside XWalk1?	N/A	N/A	Storm Grate/Utility Hazard?	N/A
N/A	Any Obstructions?	N/A			
	Obstruction Type		Yes	Storm Grate/Utility Type	N/A
		N/A	N/A	Surface Condition? (G/P)	Good
			N/A	Curb Slope (%)	13.7

Possible Solutions:				
	Remove & Replace Entire Ramp.				
	Surveyor Notes:				
	N/A				
	PROW/ADA:				
	R304.2.2, R304.5.3				
	Street 1 Name	BERKELEY AV			
	Stop Condition-Street 1	StopSign			
	Street 2 Name	N/A			
	Stop Condition-Street 2	N/A			
Total Cost:		\$	1600.00
