Access Compliance Report

Public Rights-of-Way

(Curb Ramps)

Intersection ID: 50342	Main Street: HERMISTON_ST	Cross Street: STIRLINGSHIRE_CT	Location: SW
ADA ID: E8116EE2D5C1	Ramp Type: BlendTrans1	Initial Pass/Fail: Fail	Overall Compliance: No
Severity Score: 12.5			
Codes/Mitigation Info/Possible Solution		Field Measurements/Component Compliance

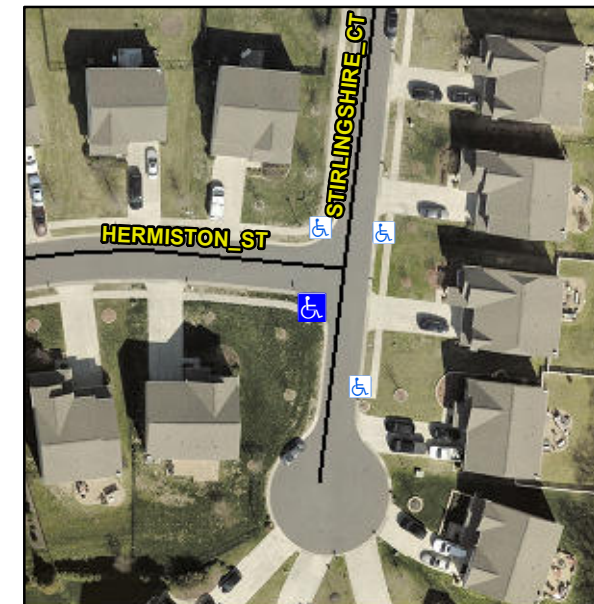
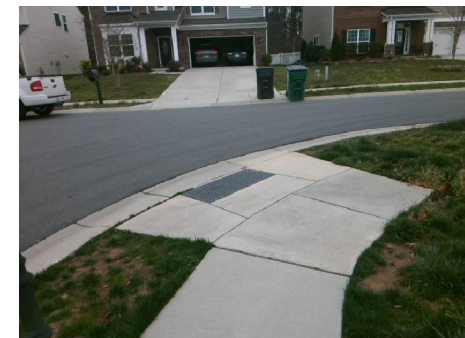
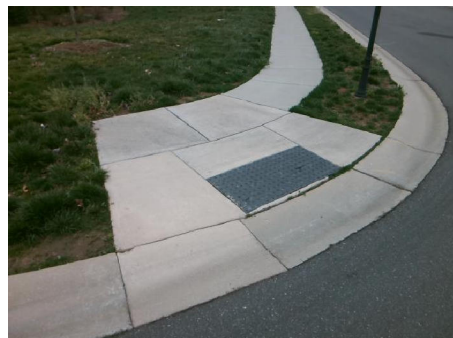
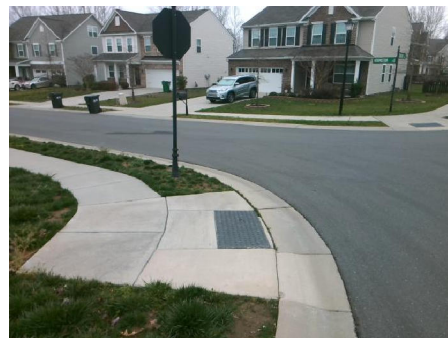
Not Found, R304.5.3

Compliance	Description	Data	Compliance	Description	Data
N/A	Ramp Length (in)	50.0	Yes	BlendTrans Slope (%)	3.2
Yes	Ramp Width (in)	48.0	No	BlendTrans XSlope (%)	5.3
N/A	Flare Type LT	N/A	N/A	Flare Type RT	N/A
N/A	Flare Slope LT (%)	N/A	N/A	Flare Slope RT (%)	N/A
N/A	Flare Traversable LT?	N/A	N/A	Flare Traversable RT?	N/A
N/A	Landing Length (in)	N/A	N/A	DWS Provided?	N/A
N/A	Landing Width (in)	N/A	N/A	DWS Contrast?	N/A
N/A	Landing Slope (%)	N/A	N/A	DWS Length (in)	N/A
N/A	Landing X Slope (%)	N/A	N/A	DWS Full Width?	N/A
N/A	Landing Curb? (Y/N)	N/A	N/A	DWS Offset (in)	N/A
N/A	Shared Landing?	N/A			
N/A	Gutter Ponding?	N/A	N/A	Gutter Slope (%)	N/A
N/A	Gutter Lip Ht (in)	N/A	N/A	Gutter X Slope (%)	N/A
N/A	Painted X Walk1?	No	N/A	Painted X Walk2?	No
	X Walk 1 Direction	To E		X Walk 2 Direction	To N
	X Walk 1 Width (in)	N/A		X Walk 2 Width (in)	N/A
	X Walk 1 Slope (%)	5.8		X Walk 2 Slope (%)	2.2
	X Walk 1 X Slope (%)	0.3		X Walk 2 X Slope (%)	6.0

N/A	Ramp inside XWalk1?	N/A	N/A	Ramp inside XWalk2?	N/A
	Road Slope (%)	4.2		Clear Space?	N/A
	Road X Slope (%)	3.3	N/A	Clear Space to XWalk (in)	N/A
N/A	Any Obstructions?	N/A	N/A	Storm Grate/Utility Hazard?	N/A
	Obstruction Type			Storm Grate/Utility Type	
		N/A			N/A
			Yes	Surface Condition? (G/P)	Good
			No	Curb Slope (%)	5.4

Remove & Replace Curb Ramp With Two New Directional Ramps or Equivalent.
