# Access Compliance Report

## Public Rights-of-Way

### (Curb Ramps)

Intersection ID: 29523	Main Street: SEDGEWOOD_CR	Cross Street: SEDGEWOOD_PLACE_CT	Location:	N
ADA ID: E81AE5A07F12	Ramp Type: PerpDiag	Initial Pass/Fail: Fail	Overall Compliance: No	Severity Score: 12.5

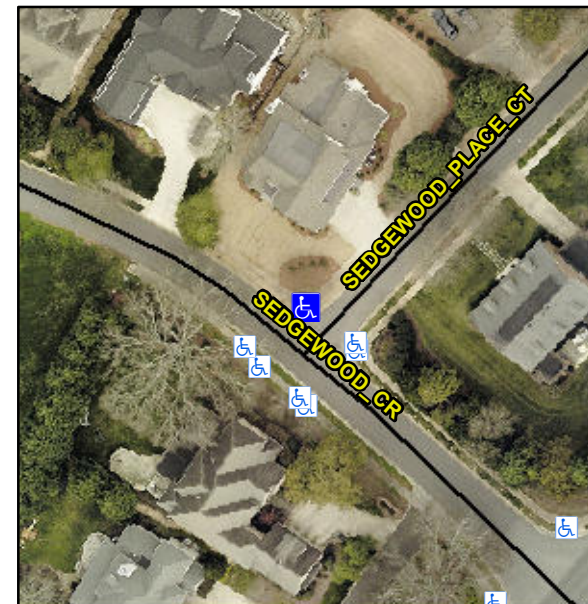
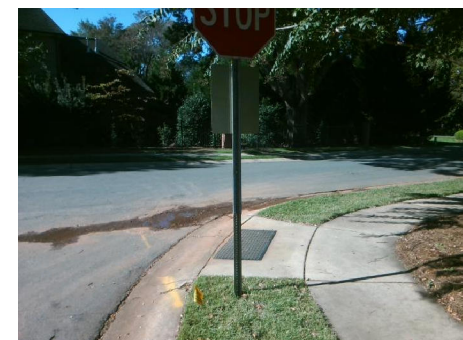
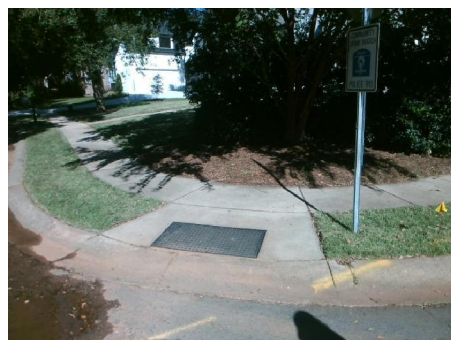
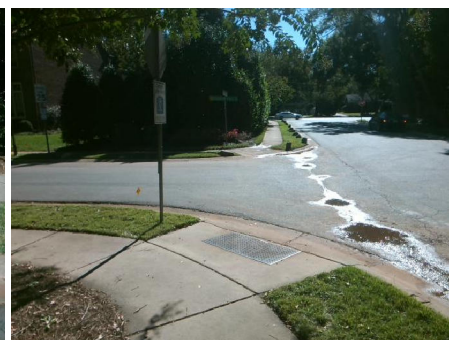
**Not Found, R304.2.2**

Compliance	Description	Data	Compliance	Description	Data
N/A	Ramp Length (in)	49.0	No	Ramp Slope (%)	8.6
Yes	Ramp Width (in)	48.0	Yes	Ramp XSlope (%)	0.2
N/A	Flare Type LT	N/A	N/A	Flare Type RT	N/A
N/A	Flare Slope LT (%)	N/A	N/A	Flare Slope RT (%)	N/A
N/A	Flare Traversable LT?	N/A	N/A	Flare Traversable RT?	N/A
N/A	Landing Length (in)	N/A	N/A	DWS Provided?	N/A
N/A	Landing Width (in)	N/A	N/A	DWS Contrast?	N/A
N/A	Landing Slope (%)	N/A	N/A	DWS Length (in)	N/A
N/A	Landing X Slope (%)	N/A	N/A	DWS Full Width?	N/A
N/A	Landing Curb? (Y/N)	N/A	N/A	DWS Offset (in)	N/A
N/A	Shared Landing?	N/A			
N/A	Gutter Ponding?	N/A	N/A	Gutter Slope (%)	N/A
N/A	Gutter Lip Ht (in)	N/A	N/A	Gutter X Slope (%)	N/A
N/A	Painted X Walk1?	No	N/A	Painted X Walk2?	No
	X Walk 1 Direction	To SW		X Walk 2 Direction	To SE
N/A	X Walk 1 Width (in)	N/A	N/A	X Walk 2 Width (in)	N/A
	X Walk 1 Slope (%)	1.2		X Walk 2 Slope (%)	3.6
	X Walk 1 X Slope (%)	2.2		X Walk 2 X Slope (%)	4.4

N/A	Ramp inside XWalk1?	N/A	N/A	Ramp inside XWalk2?	N/A
	Road Slope (%)	2.6	N/A	Clear Space?	N/A
	Road X Slope (%)	1.4	N/A	Clear Space to XWalk (in)	N/A
N/A	Any Obstructions?	N/A	N/A	Storm Grate/Utility Hazard?	N/A
	Obstruction Type			Storm Grate/Utility Type	
		N/A			N/A
			Yes	Surface Condition? (G/P)	Good

**Remove & Replace Curb Ramp With Two New Directional Ramps or Equivalent.**
