# Access Compliance Report

## Public Rights-of-Way

### (Curb Ramps)

Intersection ID: N/A	Main Street: HOOVER_CREEK_BV	Cross Street: STEELECROFT_PY	Location: NW
ADA ID: E827FC0CDC85	Ramp Type: Perp	Initial Pass/Fail: Fail	Overall Compliance: No
		Severity Score: 25

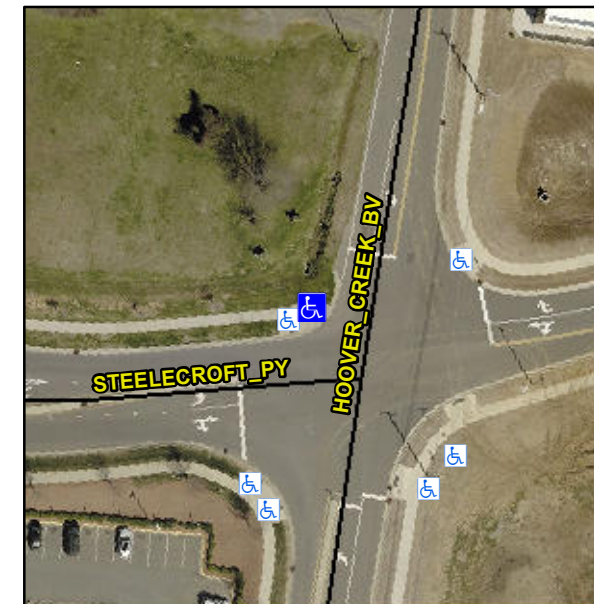
**Not Found, R304.5.3**

Compliance	Description	Data	Compliance	Description	Data
N/A	Ramp Length (in)	96.0	Yes	Ramp Slope (%)	8.0
Yes	Ramp Width (in)	48.0	No	Ramp XSlope (%)	8.5
N/A	Flare Type LT	N/A	N/A	Flare Type RT	N/A
N/A	Flare Slope LT (%)	N/A	N/A	Flare Slope RT (%)	N/A
N/A	Flare Traversable LT?	N/A	N/A	Flare Traversable RT?	N/A
N/A	Landing Length (in)	N/A	N/A	DWS Provided?	N/A
N/A	Landing Width (in)	N/A	N/A	DWS Contrast?	N/A
N/A	Landing Slope (%)	N/A	N/A	DWS Length (in)	N/A
N/A	Landing X Slope (%)	N/A	N/A	DWS Full Width?	N/A
N/A	Landing Curb? (Y/N)	N/A	N/A	DWS Offset (in)	N/A
N/A	Shared Landing?	N/A			
N/A	Gutter Ponding?	N/A	N/A	Gutter Slope (%)	N/A
N/A	Gutter Lip Ht (in)	N/A	N/A	Gutter X Slope (%)	N/A
N/A	Painted X Walk1?	No	N/A	Painted X Walk2?	N/A
	X Walk 1 Direction	To NE		X Walk 2 Direction	N/A
N/A	X Walk 1 Width (in)	N/A	N/A	X Walk 2 Width (in)	N/A
	X Walk 1 Slope (%)	5.8		X Walk 2 Slope (%)	N/A
	X Walk 1 X Slope (%)	1.2		X Walk 2 X Slope (%)	N/A

**Remove & Replace Entire Ramp.**

Total Cost: \$ 1850.00
