# Access Compliance Report

## Public Rights-of-Way

### (Curb Ramps)

Intersection ID: 12863	Main Street: E_3RD_ST	Cross Street: S_CALDWELL_ST	Location: NE
ADA ID: E82A4AC99D3C	Ramp Type: Perp	Initial Pass/Fail: Fail	Overall Compliance: No
Severity Score: 26.25			
Codes/Mitigation Info/Possible Solution		Field Measurements/Component Compliance

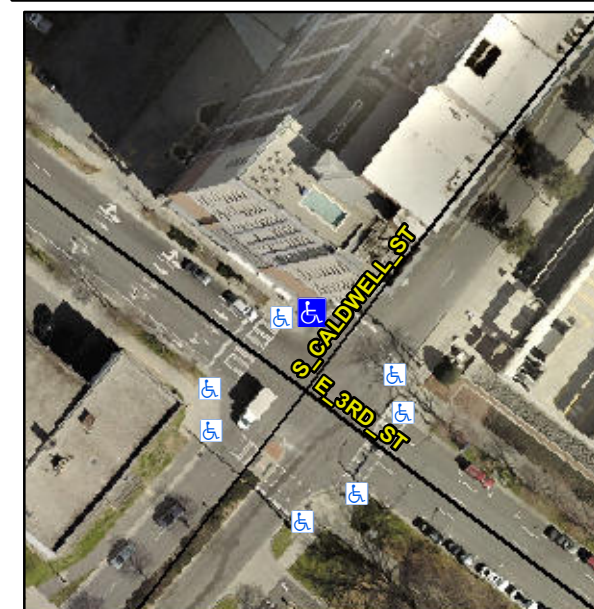
Compliance	Description	Data	Compliance	Description	Data
N/A	Ramp Length (in)	80.0	No	Ramp Slope (%)	13.3
Yes	Ramp Width (in)	48.0	Yes	Ramp XSlope (%)	3.0
N/A	Flare Type LT	N/A	N/A	Flare Type RT	N/A
N/A	Flare Slope LT (%)	N/A	N/A	Flare Slope RT (%)	N/A
N/A	Flare Traversable LT?	N/A	N/A	Flare Traversable RT?	N/A
N/A	Landing Length (in)	N/A	N/A	DWS Provided?	N/A
N/A	Landing Width (in)	N/A	N/A	DWS Contrast?	N/A
N/A	Landing Slope (%)	N/A	N/A	DWS Length (in)	N/A
N/A	Landing X Slope (%)	N/A	N/A	DWS Full Width?	N/A
N/A	Landing Curb? (Y/N)	N/A	N/A	DWS Offset (in)	N/A
N/A	Shared Landing?	N/A			
N/A	Gutter Ponding?	N/A	N/A	Gutter Slope (%)	N/A
N/A	Gutter Lip Ht (in)	N/A	N/A	Gutter X Slope (%)	N/A
N/A	Painted X Walk1?	Yes	N/A	Painted X Walk2?	N/A
	X Walk 1 Direction	To SE		X Walk 2 Direction	N/A
N/A	X Walk 1 Width (in)	122.0	N/A	X Walk 2 Width (in)	N/A
	X Walk 1 Slope (%)	0.6		X Walk 2 Slope (%)	N/A
	X Walk 1 X Slope (%)	3.6		X Walk 2 X Slope (%)	N/A

N/A	Ramp inside XWalk1?	Yes	N/A	Ramp inside XWalk2?	N/A
	Road Slope (%)	N/A	N/A	Clear Space?	N/A
	Road X Slope (%)	N/A	N/A	Clear Space to XWalk (in)	N/A
N/A	Any Obstructions?	N/A	N/A	Storm Grate/Utility Hazard?	N/A
	Obstruction Type			Storm Grate/Utility Type	
		N/A			N/A
		Yes		Surface Condition? (G/P)	Good

Possible Solutions:

**Remove & Replace Entire Ramp.**

**R304.2.2**
