# Access Compliance Report

## Public Rights-of-Way

### (Curb Ramps)

| Intersection ID: 10445 | Main Street: E_34TH_ST | Cross Street: N_MCDOWELL_ST | Location: SW |

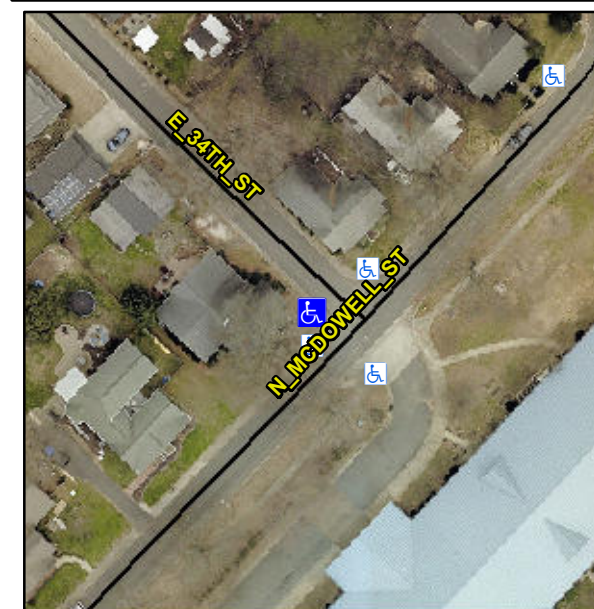
| ADA ID: E83EB0D65C65 | Ramp Type: Perp | Initial Pass/Fail: Fail | Overall Compliance: No |

**Not Found, R304.5.3**

| Compliance | Description | Data | Compliance | Description | Data |
|---|---|---|---|---|---|
| Yes | Ramp Width (in) | 48.0 | No | Ramp XSlope (%) | 7.1 |

**Remove & Replace Entire Ramp.**

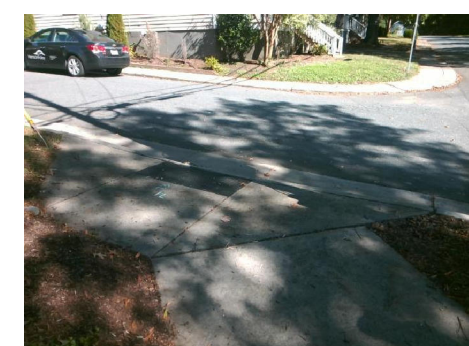
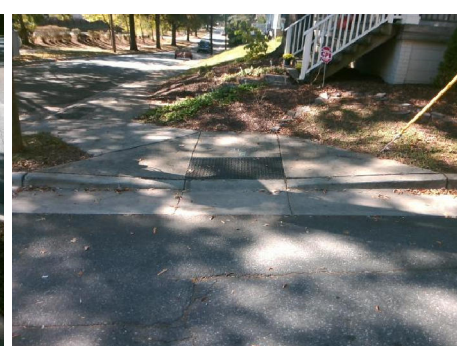
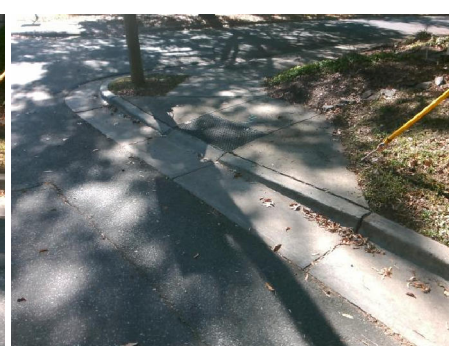
| Compliance | Description | Data | Compliance | Description | Data |
|---|---|---|---|---|---|
| | | Yes | | Surface Condition? (G/P) | Good |
