Access Compliance Report

Public Rights-of-Way

(Curb Ramps)

| Intersection ID: 13137 | Main Street: CENTRAL_AV | Cross Street: THOMAS_AV | Location: NE |

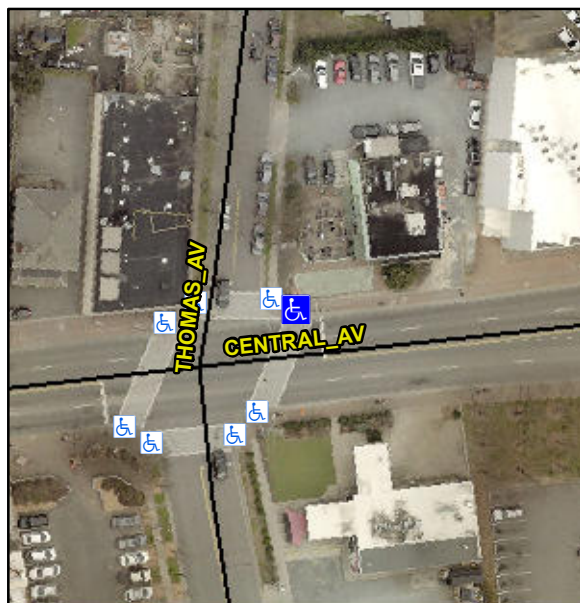
| ADA ID: E8402D9D8A82 | Ramp Type: Perp | Initial Pass/Fail: Fail | Overall Compliance: No |
| Severity Score: 12.5 | | | |

Not Found, R304.2.2

| Compliance | Description | Data | Compliance | Description | Data |
|---|---|---|---|---|---|
| N/A | Ramp Length (in) | 66.0 | No | Ramp Slope (%) | 8.4 |

Possible Solutions:

Remove & Replace Entire Ramp.
