Access Compliance Report

Public Rights-of-Way

(Curb Ramps)

Intersection ID: 8793	Main Street: BARRINGTON_DR	Cross Street: WOODFIELD_DR	Location: S
ADA ID: E86068048AEA	Ramp Type: Perp	Initial Pass/Fail: Fail	Overall Compliance: No
Severity Score: 1.25			
Codes/Mitigation Info/Possible Solution		Field Measurements/Component Compliance

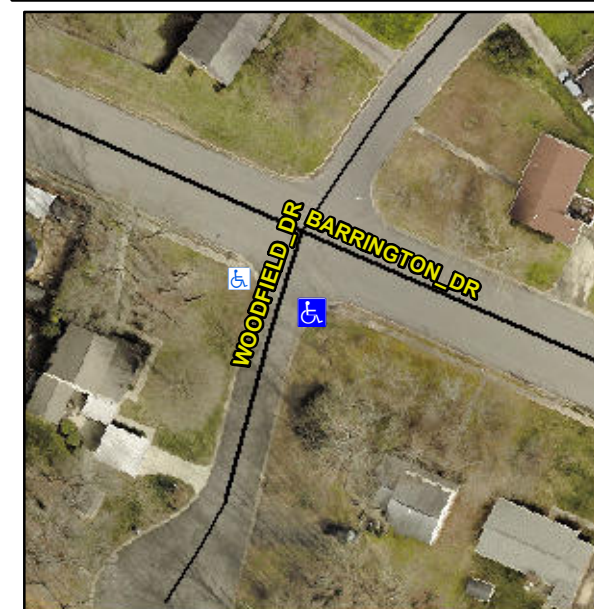
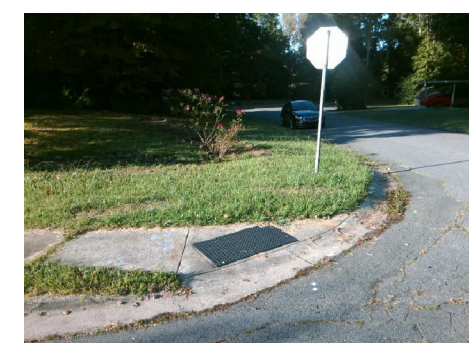
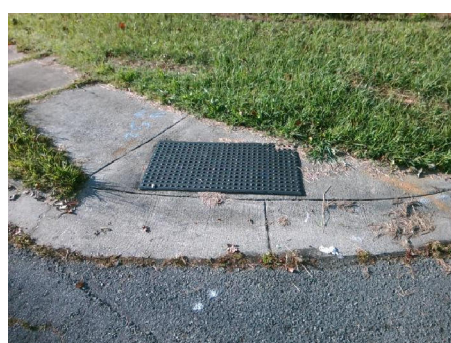
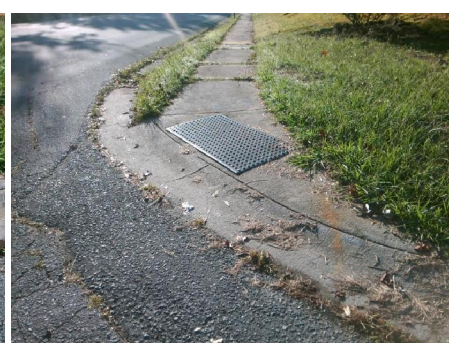
Not Found, R304.5.3

Compliance	Description	Data	Compliance	Description	Data
N/A	Ramp Length (in)	25.0	Yes	Ramp Slope (%)	5.2
Yes	Ramp Width (in)	48.0	No	Ramp XSlope (%)	2.2
N/A	Flare Type LT	N/A	N/A	Flare Type RT	N/A
N/A	Flare Slope LT (%)	N/A	N/A	Flare Slope RT (%)	N/A
N/A	Flare Traversable LT?	N/A	N/A	Flare Traversable RT?	N/A
N/A	Landing Length (in)	N/A	N/A	DWS Provided?	N/A
N/A	Landing Width (in)	N/A	N/A	DWS Contrast?	N/A
N/A	Landing Slope (%)	N/A	N/A	DWS Length (in)	N/A
N/A	Landing X Slope (%)	N/A	N/A	DWS Full Width?	N/A
N/A	Landing Curb? (Y/N)	N/A	N/A	DWS Offset (in)	N/A
N/A	Shared Landing?	N/A			
N/A	Gutter Ponding?	N/A	N/A	Gutter Slope (%)	N/A
N/A	Gutter Lip Ht (in)	N/A	N/A	Gutter X Slope (%)	N/A
N/A	Painted X Walk1?	No	N/A	Painted X Walk2?	N/A
	X Walk 1 Direction	To NW		X Walk 2 Direction	N/A
N/A	X Walk 1 Width (in)	N/A	N/A	X Walk 2 Width (in)	N/A
	X Walk 1 Slope (%)	1.1		X Walk 2 Slope (%)	N/A
	X Walk 1 X Slope (%)	0.3		X Walk 2 X Slope (%)	N/A

N/A	Ramp inside XWalk1?	N/A	N/A	Ramp inside XWalk2?	N/A
	Road Slope (%)	N/A	N/A	Clear Space?	N/A
	Road X Slope (%)	N/A	N/A	Clear Space to XWalk (in)	N/A
N/A	Any Obstructions?	N/A	N/A	Storm Grate/Utility Hazard?	N/A
	Obstruction Type			Storm Grate/Utility Type	
		N/A			N/A
			Yes	Surface Condition? (G/P)	Good

Remove & Replace Entire Ramp.
