Access Compliance Report

Public Rights-of-Way

(Curb Ramps)

Intersection ID: 43474	Main Street: LIONESS_ST	Cross Street: LIONS_MANE_ST	Location: SW
ADA ID: E861CF02B7E9	Ramp Type: PerpDiag	Initial Pass/Fail: Fail	Overall Compliance: No
Severity Score: 8.75			
Codes/Mitigation Info/Possible Solution		Field Measurements/Component Compliance

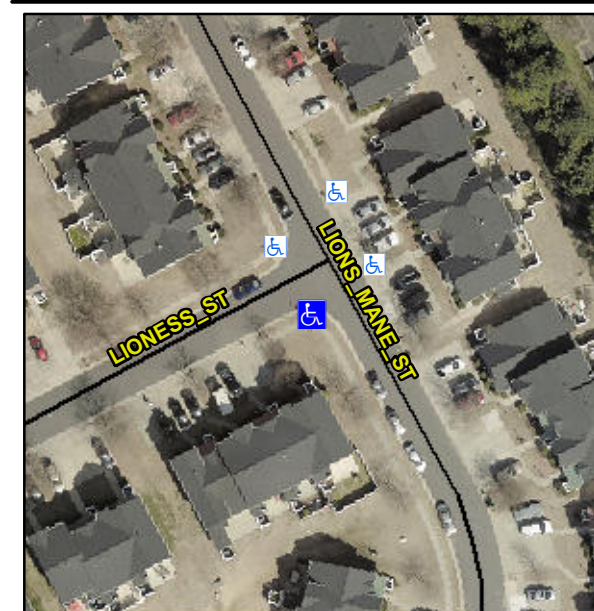
Not Found, R304.5.1

Compliance	Description	Data	Compliance	Description	Data
N/A	Ramp Length (in)	48.0	Yes	Ramp Slope (%)	7.8
No	Ramp Width (in)	40.0	Yes	Ramp XSlope (%)	1.5
N/A	Flare Type LT	N/A	N/A	Flare Type RT	N/A
N/A	Flare Slope LT (%)	N/A	N/A	Flare Slope RT (%)	N/A
N/A	Flare Traversable LT?	N/A	N/A	Flare Traversable RT?	N/A
N/A	Landing Length (in)	N/A	N/A	DWS Provided?	N/A
N/A	Landing Width (in)	N/A	N/A	DWS Contrast?	N/A
N/A	Landing Slope (%)	N/A	N/A	DWS Length (in)	N/A
N/A	Landing X Slope (%)	N/A	N/A	DWS Full Width?	N/A
N/A	Landing Curb? (Y/N)	N/A	N/A	DWS Offset (in)	N/A
N/A	Shared Landing?	N/A			
N/A	Gutter Ponding?	N/A	N/A	Gutter Slope (%)	N/A
N/A	Gutter Lip Ht (in)	N/A	N/A	Gutter X Slope (%)	N/A
N/A	Painted X Walk1?	No	N/A	Painted X Walk2?	No
	X Walk 1 Direction	To E		X Walk 2 Direction	To N
N/A	X Walk 1 Width (in)	N/A	N/A	X Walk 2 Width (in)	N/A
	X Walk 1 Slope (%)	4.4		X Walk 2 Slope (%)	2.8
	X Walk 1 X Slope (%)	0.6		X Walk 2 X Slope (%)	2.2

N/A	Ramp inside XWalk1?	N/A	N/A	Ramp inside XWalk2?	N/A
	Road Slope (%)	0.9	N/A	Clear Space?	N/A
	Road X Slope (%)	1.4	N/A	Clear Space to XWalk (in)	N/A
N/A	Any Obstructions?	N/A	N/A	Storm Grate/Utility Hazard?	N/A
	Obstruction Type			Storm Grate/Utility Type	
		N/A			N/A
		Yes		Surface Condition? (G/P)	Good

Remove & Replace Curb Ramp With Two New Directional Ramps or Equivalent.
