Access Compliance Report Public Rights-of-Way (Curb Ramps)

Intersection ID: 5124 Main Street: GIBBON RD **Cross Street: OLD STATESVILLE RD** Location: N ADA ID: E86EE54C5CBE Ramp Type: Perp Initial Pass/Fail: Fail **Overall Compliance: No Severity Score:** 25

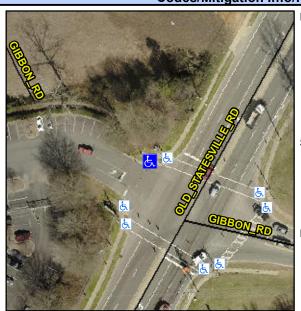
12.3

0.8

62.0 No

Possible Solution	
Possible Solutions:	
Remove & Replace Entire Ramp.	
Surveyor Notes:	
N/A	
DDOWADA.	
PROW/ADA:	
Not Found, R304.2.2

N/A
PROW/ADA:		N/A
Not Found, R304.2.2		N/A
		N/A
Total Cost:	\$ 1850.00
