# Access Compliance Report

## Public Rights-of-Way

### (Curb Ramps)

Intersection ID: 14612	Main Street: ELI_ST	Cross Street: BAXTER_ST	Location: NE
ADA ID: E86FF8C45B89	Ramp Type: PerpDiag	Initial Pass/Fail: Fail	Overall Compliance: No
			Severity Score: 21.25

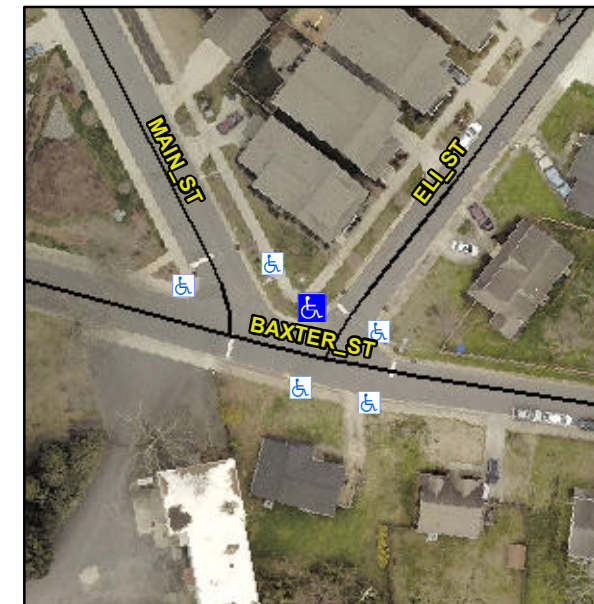
**Not Found, R304.5.1, R304.2.2**

Compliance	Description	Data	Compliance	Description	Data
N/A	Ramp Length (in)	102.0	No	Ramp Slope (%)	9.2
No	Ramp Width (in)	46.0	Yes	Ramp XSlope (%)	1.3
N/A	Flare Type LT	N/A	N/A	Flare Type RT	N/A
N/A	Flare Slope LT (%)	N/A	N/A	Flare Slope RT (%)	N/A
N/A	Flare Traversable LT?	N/A	N/A	Flare Traversable RT?	N/A
N/A	Landing Length (in)	N/A	N/A	DWS Provided?	N/A
N/A	Landing Width (in)	N/A	N/A	DWS Contrast?	N/A
N/A	Landing Slope (%)	N/A	N/A	DWS Length (in)	N/A
N/A	Landing X Slope (%)	N/A	N/A	DWS Full Width?	N/A
N/A	Landing Curb? (Y/N)	N/A	N/A	DWS Offset (in)	N/A
N/A	Shared Landing?	N/A			
N/A	Gutter Ponding?	N/A	N/A	Gutter Slope (%)	N/A
N/A	Gutter Lip Ht (in)	N/A	N/A	Gutter X Slope (%)	N/A
N/A	Painted X Walk1?	No	N/A	Painted X Walk2?	No
	X Walk 1 Direction	To S		X Walk 2 Direction	To SE
N/A	X Walk 1 Width (in)	N/A	N/A	X Walk 2 Width (in)	N/A
	X Walk 1 Slope (%)	2.1		X Walk 2 Slope (%)	0.4
	X Walk 1 X Slope (%)	0.4		X Walk 2 X Slope (%)	1.9

N/A	Ramp inside XWalk1?	N/A	N/A	Ramp inside XWalk2?	N/A
	Road Slope (%)	0.1	N/A	Clear Space?	N/A
	Road X Slope (%)	1.0	N/A	Clear Space to XWalk (in)	N/A
N/A	Any Obstructions?	N/A	N/A	Storm Grate/Utility Hazard?	N/A
	Obstruction Type			Storm Grate/Utility Type	
		N/A			N/A
			Yes	Surface Condition? (G/P)	Good

**Remove & Replace Curb Ramp With Two New Directional Ramps or Equivalent.**

Total Cost: \$ 3200.00
