Access Compliance Report

Public Rights-of-Way

(Curb Ramps)

Intersection ID: 47099	Main Street: GALLERIA_BV	Cross Street: N/A	Location: S
ADA ID: E876C139144C	Ramp Type: Perp	Initial Pass/Fail: Fail	Overall Compliance: No
Severity Score: 21.25			
Codes/Mitigation Info/Possible Solution		Field Measurements/Component Compliance

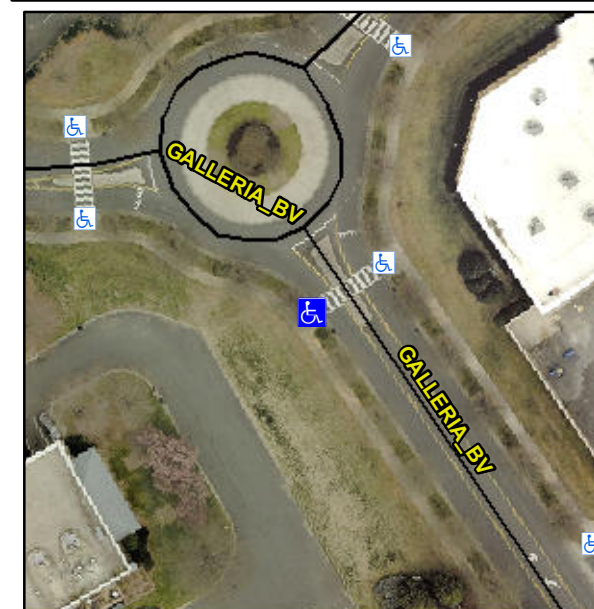
R304.5.1, R304.2.2

Compliance	Description	Data	Compliance	Description	Data
N/A	Ramp Length (in)	97.0	No	Ramp Slope (%)	8.7
No	Ramp Width (in)	44.0	Yes	Ramp XSlope (%)	0.1
N/A	Flare Type LT	N/A	N/A	Flare Type RT	N/A
N/A	Flare Slope LT (%)	N/A	N/A	Flare Slope RT (%)	N/A
N/A	Flare Traversable LT?	N/A	N/A	Flare Traversable RT?	N/A
N/A	Landing Length (in)	N/A	N/A	DWS Provided?	N/A
N/A	Landing Width (in)	N/A	N/A	DWS Contrast?	N/A
N/A	Landing Slope (%)	N/A	N/A	DWS Length (in)	N/A
N/A	Landing X Slope (%)	N/A	N/A	DWS Full Width?	N/A
N/A	Landing Curb? (Y/N)	N/A	N/A	DWS Offset (in)	N/A
N/A	Shared Landing?	N/A			
N/A	Gutter Ponding?	N/A	N/A	Gutter Slope (%)	N/A
N/A	Gutter Lip Ht (in)	N/A	N/A	Gutter X Slope (%)	N/A
N/A	Painted X Walk1?	Yes	N/A	Painted X Walk2?	N/A
	X Walk 1 Direction	To NE		X Walk 2 Direction	N/A
N/A	X Walk 1 Width (in)	98.0	N/A	X Walk 2 Width (in)	N/A
	X Walk 1 Slope (%)	2.1		X Walk 2 Slope (%)	N/A
	X Walk 1 X Slope (%)	0.3		X Walk 2 X Slope (%)	N/A

N/A	Ramp inside XWalk1?	Yes	N/A	Ramp inside XWalk2?	N/A
	Road Slope (%)	N/A	N/A	Clear Space?	N/A
	Road X Slope (%)	N/A	N/A	Clear Space to XWalk (in)	N/A
N/A	Any Obstructions?	N/A	N/A	Storm Grate/Utility Hazard?	N/A
	Obstruction Type			Storm Grate/Utility Type	
		N/A			N/A
		Yes		Surface Condition? (G/P)	Good

Possible Solutions:

Remove & Replace Entire Ramp.
