Access Compliance Report

Public Rights-of-Way

(Curb Ramps)

Intersection ID: 9739	Main Street: FAIRFIELD_ST	Cross Street: PATTON_AV	Location: W
ADA ID: E8837F1901A0	Ramp Type: PerpDiag	Initial Pass/Fail: Fail	Overall Compliance: No
			Severity Score: 33.75

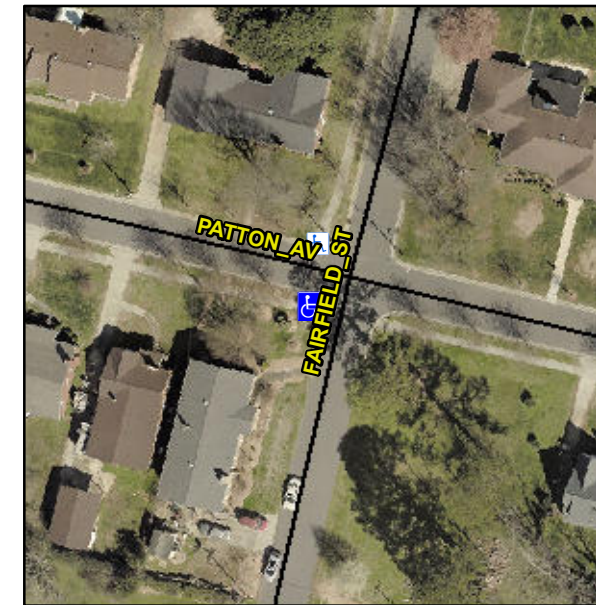
Not Found, R304.5.1, R304.5.3

Compliance	Description	Data	Compliance	Description	Data
N/A	Ramp Length (in)	110.0	Yes	Ramp Slope (%)	5.7
No	Ramp Width (in)	47.5	No	Ramp XSlope (%)	7.4
N/A	Flare Type LT	N/A	N/A	Flare Type RT	N/A
N/A	Flare Slope LT (%)	N/A	N/A	Flare Slope RT (%)	N/A
N/A	Flare Traversable LT?	N/A	N/A	Flare Traversable RT?	N/A
N/A	Landing Length (in)	N/A	N/A	DWS Provided?	N/A
N/A	Landing Width (in)	N/A	N/A	DWS Contrast?	N/A
N/A	Landing Slope (%)	N/A	N/A	DWS Length (in)	N/A
N/A	Landing X Slope (%)	N/A	N/A	DWS Full Width?	N/A
N/A	Landing Curb? (Y/N)	N/A	N/A	DWS Offset (in)	N/A
N/A	Shared Landing?	N/A			
N/A	Gutter Ponding?	N/A	N/A	Gutter Slope (%)	N/A
N/A	Gutter Lip Ht (in)	N/A	N/A	Gutter X Slope (%)	N/A
N/A	Painted X Walk1?	No	N/A	Painted X Walk2?	No
	X Walk 1 Direction	To SE		X Walk 2 Direction	To NE
N/A	X Walk 1 Width (in)	N/A	N/A	X Walk 2 Width (in)	N/A
	X Walk 1 Slope (%)	3.3		X Walk 2 Slope (%)	4.5
	X Walk 1 X Slope (%)	3.9		X Walk 2 X Slope (%)	4.1

N/A	Ramp inside XWalk1?	N/A	N/A	Ramp inside XWalk2?	N/A
	Road Slope (%)	5.2	N/A	Clear Space?	N/A
	Road X Slope (%)	2.7	N/A	Clear Space to XWalk (in)	N/A
N/A	Any Obstructions?	N/A	N/A	Storm Grate/Utility Hazard?	N/A
	Obstruction Type			Storm Grate/Utility Type	
		N/A			N/A
			Yes	Surface Condition? (G/P)	Good

Remove & Replace Curb Ramp With Two New Directional Ramps or Equivalent.
