Access Compliance Report

Public Rights-of-Way

(Curb Ramps)

Intersection ID: 11460	Main Street: PALM_AV	Cross Street: CARDIFF_AV	Location: NW
ADA ID: E891419DE8F8	Ramp Type: Perp	Initial Pass/Fail: Fail	Overall Compliance: No
		Severity Score: 10

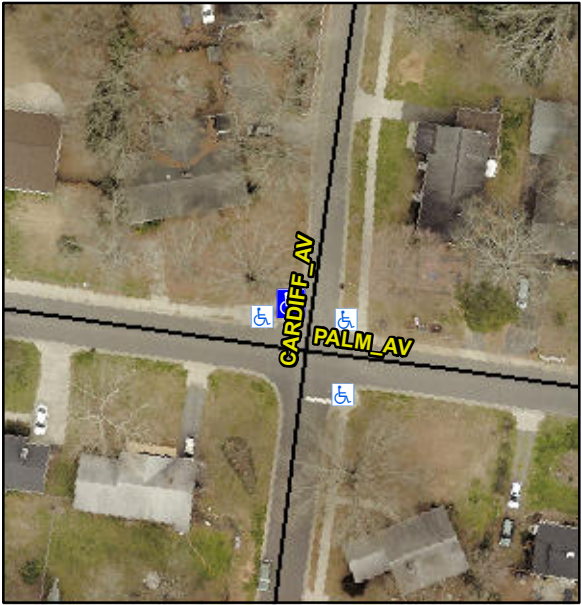
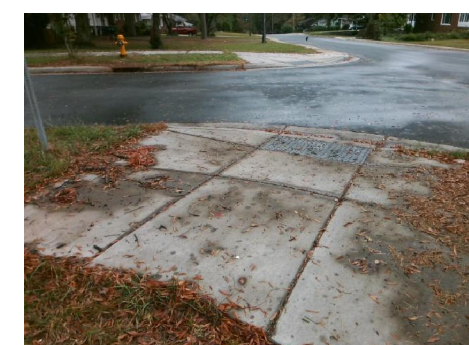
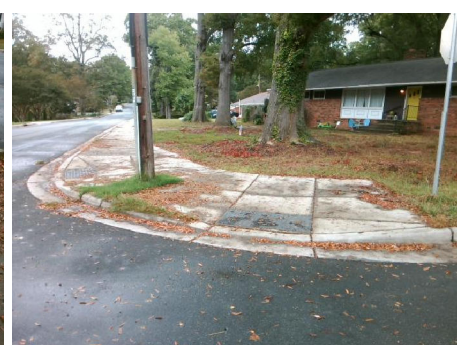
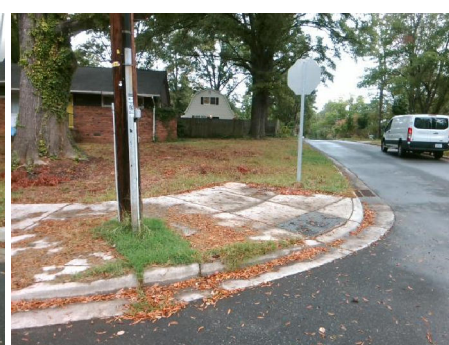
Possible Solutions:		Compliance	Description	Data
	Remove & Replace Entire Ramp.		Yes	Ramp Length (in)	62.0
			No	Ramp Width (in)	47.0
			N/A	Flare Type LT	N/A
			N/A	Flare Slope LT (%)	N/A
			N/A	Flare Traversable LT?	N/A
			N/A	Landing Length (in)	N/A
			N/A	Landing Width (in)	N/A
			N/A	Landing Slope (%)	N/A
			N/A	Landing X Slope (%)	N/A
<p>Surveyor Notes:</p> <p>N/A</p> <p>PROW/ADA:</p> <p>Not Found, R304.5.1, R304.5.3</p>			N/A	Flare Type RT	N/A
			N/A	Flare Slope RT (%)	N/A
			N/A	Flare Traversable RT?	N/A
			N/A	DWS Provided?	N/A
			N/A	DWS Contrast?	N/A
			N/A	DWS Length (in)	N/A
			N/A	DWS Full Width?	N/A
			N/A	DWS Offset (in)	N/A
			N/A	Gutter Ponding?	N/A
			N/A	Gutter Lip Ht (in)	N/A
			No	Painted X Walk1?	N/A
			To E	X Walk 1 Direction	N/A
			N/A	X Walk 1 Width (in)	N/A

1.9	X Walk 1 Slope (%)	N/A
			1.4	X Walk 1 X Slope (%)	N/A
			N/A	Ramp inside XWalk1?	N/A
			N/A	Road Slope (%)	N/A
			N/A	Road X Slope (%)	N/A
			N/A	Any Obstructions?	N/A
				Obstruction Type	N/A
Total Cost:		\$ 1850.00	N/A	Clear Space?	N/A
			N/A	Clear Space to XWalk (in)	N/A
			N/A	Storm Grate/Utility Hazard?	N/A
				Storm Grate/Utility Type	N/A
			Yes	Surface Condition? (G/P)	Good
