# Access Compliance Report

## Public Rights-of-Way

### (Curb Ramps)

Intersection ID: 20207	Main Street: CEDAR_HILL_DR	Cross Street: ILLORIA_DR	Location: SE
ADA ID: E8946F929627	Ramp Type: PerpDiag	Initial Pass/Fail: Fail	Overall Compliance: No
			Severity Score: 13.75

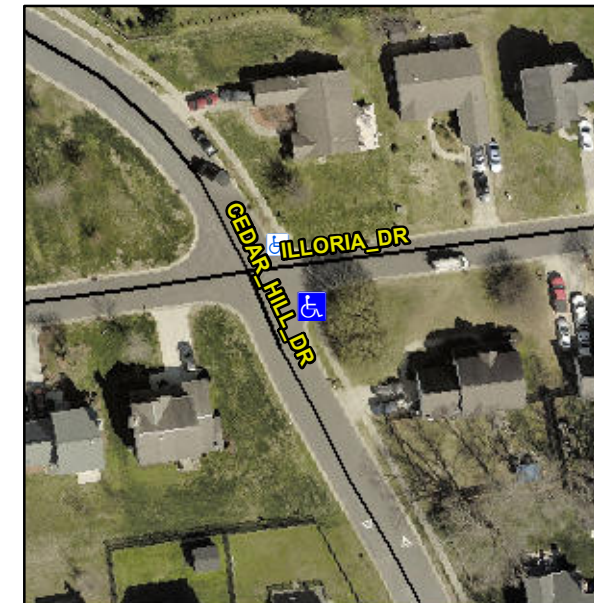
Compliance	Description	Data	Compliance	Description	Data
N/A	Ramp Length (in)	49.0	No	Ramp Slope (%)	11.4
Yes	Ramp Width (in)	52.0	No	Ramp XSlope (%)	4.5
N/A	Flare Type LT	N/A	N/A	Flare Type RT	N/A
N/A	Flare Slope LT (%)	N/A	N/A	Flare Slope RT (%)	N/A
N/A	Flare Traversable LT?	N/A	N/A	Flare Traversable RT?	N/A
N/A	Landing Length (in)	N/A	N/A	DWS Provided?	N/A
N/A	Landing Width (in)	N/A	N/A	DWS Contrast?	N/A
N/A	Landing Slope (%)	N/A	N/A	DWS Length (in)	N/A
N/A	Landing X Slope (%)	N/A	N/A	DWS Full Width?	N/A
N/A	Landing Curb? (Y/N)	N/A	N/A	DWS Offset (in)	N/A
N/A	Shared Landing?	N/A			
N/A	Gutter Ponding?	N/A	N/A	Gutter Slope (%)	N/A
N/A	Gutter Lip Ht (in)	N/A	N/A	Gutter X Slope (%)	N/A
N/A	Painted X Walk1?	No	N/A	Painted X Walk2?	No
	X Walk 1 Direction	To NW		X Walk 2 Direction	To W
N/A	X Walk 1 Width (in)	N/A	N/A	X Walk 2 Width (in)	N/A
	X Walk 1 Slope (%)	5.2		X Walk 2 Slope (%)	6.0
	X Walk 1 X Slope (%)	0.9		X Walk 2 X Slope (%)	6.3

N/A	Ramp inside XWalk1?	N/A	N/A	Ramp inside XWalk2?	N/A
	Road Slope (%)	3.0	N/A	Clear Space?	N/A
	Road X Slope (%)	2.3	N/A	Clear Space to XWalk (in)	N/A
N/A	Any Obstructions?	N/A	N/A	Storm Grate/Utility Hazard?	N/A
	Obstruction Type			Storm Grate/Utility Type	
		N/A			N/A
			Yes	Surface Condition? (G/P)	Good

**Remove & Replace Curb Ramp With Two New Directional Ramps or Equivalent.**

**R304.2.2, R304.5.3**
