# Access Compliance Report

## Public Rights-of-Way

### (Curb Ramps)

Intersection ID: 19826	Main Street: THERMAL_RD	Cross Street: PATIMBY_RD	Location: NE
ADA ID: E89916CECD69	Ramp Type: PerpDiag	Initial Pass/Fail: Fail	Overall Compliance: No
Codes/Mitigation Info/Possible Solution		Field Measurements/Component Compliance	
Severity Score: 13.75

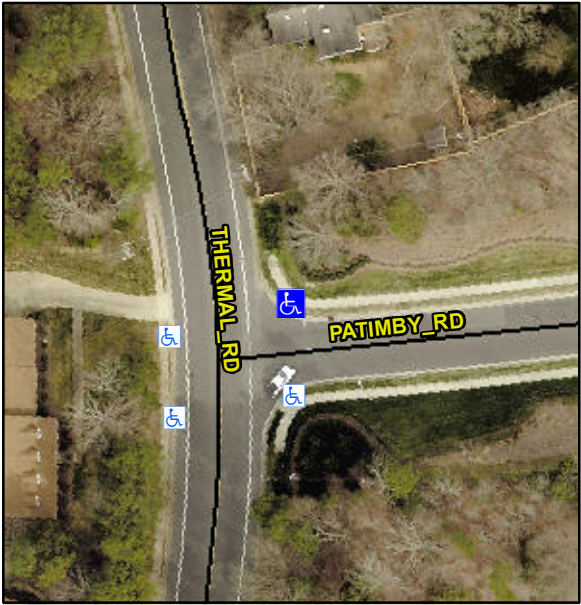
Possible Solutions:		Compliance	Description	Data	Compliance	Description	Data
	Remove & Replace Curb Ramp With Two New Directional Ramps or Equivalent.		N/A	Ramp Length (in)	48.0	No	Ramp Slope (%)	10.4
<p>Surveyor Notes:</p> <p>N/A</p>			Yes	Ramp Width (in)	48.0	No	Ramp XSlope (%)	2.6
			N/A	Flare Type LT	N/A	N/A	Flare Type RT	N/A
<p>PROW/ADA:</p> <p>R304.2.2, R304.5.3</p>			N/A	Flare Slope LT (%)	N/A	N/A	Flare Slope RT (%)	N/A
			N/A	Flare Traversable LT?	N/A	N/A	Flare Traversable RT?	N/A
			N/A	Landing Length (in)	N/A	N/A	DWS Provided?	N/A
			N/A	Landing Width (in)	N/A	N/A	DWS Contrast?	N/A
			N/A	Landing Slope (%)	N/A	N/A	DWS Length (in)	N/A
			N/A	Landing X Slope (%)	N/A	N/A	DWS Full Width?	N/A
			N/A	Landing Curb? (Y/N)	N/A	N/A	DWS Offset (in)	N/A
			N/A	Shared Landing?	N/A			
			N/A	Gutter Ponding?	N/A	N/A	Gutter Slope (%)	N/A
			N/A	Gutter Lip Ht (in)	N/A	N/A	Gutter X Slope (%)	N/A
			N/A	Painted X Walk1?	No	N/A	Painted X Walk2?	No

X Walk 1 Direction	To W		X Walk 2 Direction	To S
			N/A	X Walk 1 Width (in)	N/A	N/A	X Walk 2 Width (in)	N/A
				X Walk 1 Slope (%)	2.9		X Walk 2 Slope (%)	0.3
				X Walk 1 X Slope (%)	0.9		X Walk 2 X Slope (%)	3.5
			N/A	Ramp inside XWalk1?	N/A	N/A	Ramp inside XWalk2?	N/A
				Road Slope (%)	2.6	N/A	Clear Space?	N/A
				Road X Slope (%)	0.8	N/A	Clear Space to XWalk (in)	N/A
			N/A	Any Obstructions?	N/A	N/A	Storm Grate/Utility Hazard?	N/A
				Obstruction Type			Storm Grate/Utility Type	
						N/A		N/A
						Yes	Surface Condition? (G/P)	Good

Total Cost: \$ 3200.00
