Access Compliance Report

Public Rights-of-Way

(Curb Ramps)

Intersection ID: 43687	Main Street: PORTSTEWART_LN	Cross Street: TODDINGTON_LN	Location: SW
ADA ID: E89B61114362	Ramp Type: BlendTrans1	Initial Pass/Fail: Fail	Overall Compliance: No
		Severity Score: 8.75

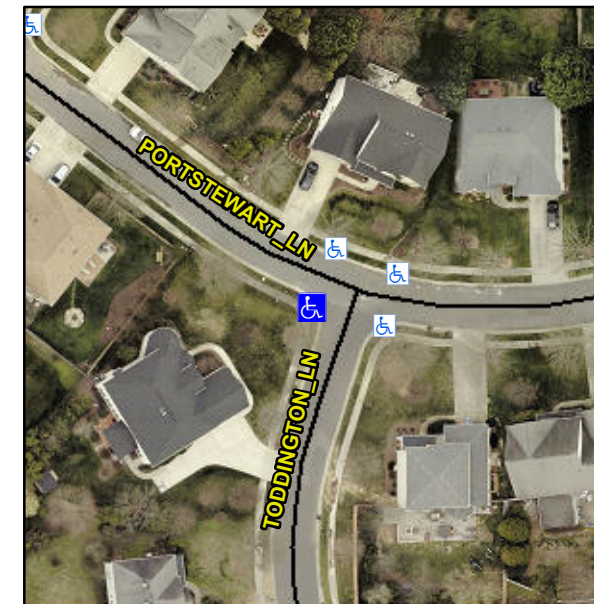
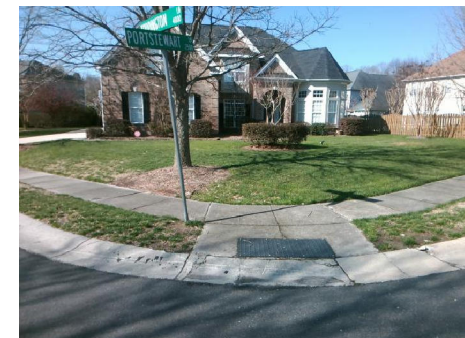
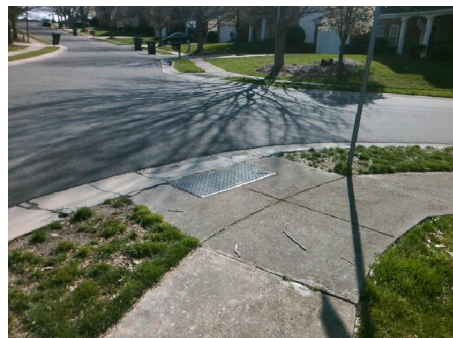
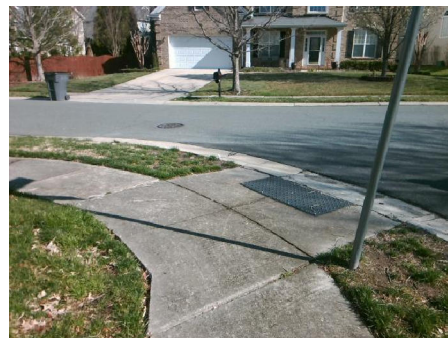
Not Found, R304.5.1

Compliance	Description	Data	Compliance	Description	Data
N/A	Ramp Length (in)	50.0	Yes	BlendTrans Slope (%)	3.2
No	Ramp Width (in)	45.0	Yes	BlendTrans XSlope (%)	0.8
N/A	Flare Type LT	N/A	N/A	Flare Type RT	N/A
N/A	Flare Slope LT (%)	N/A	N/A	Flare Slope RT (%)	N/A
N/A	Flare Traversable LT?	N/A	N/A	Flare Traversable RT?	N/A
N/A	Landing Length (in)	N/A	N/A	DWS Provided?	N/A
N/A	Landing Width (in)	N/A	N/A	DWS Contrast?	N/A
N/A	Landing Slope (%)	N/A	N/A	DWS Length (in)	N/A
N/A	Landing X Slope (%)	N/A	N/A	DWS Full Width?	N/A
N/A	Landing Curb? (Y/N)	N/A	N/A	DWS Offset (in)	N/A
N/A	Shared Landing?	N/A			
N/A	Gutter Ponding?	N/A	N/A	Gutter Slope (%)	N/A
N/A	Gutter Lip Ht (in)	N/A	N/A	Gutter X Slope (%)	N/A
N/A	Painted X Walk1?	No	N/A	Painted X Walk2?	No
	X Walk 1 Direction	To E		X Walk 2 Direction	To N
	X Walk 1 Width (in)	N/A		X Walk 2 Width (in)	N/A
	X Walk 1 Slope (%)	4.2		X Walk 2 Slope (%)	4.3
	X Walk 1 X Slope (%)	3.4		X Walk 2 X Slope (%)	2.5

N/A	Ramp inside XWalk1?	N/A	N/A	Ramp inside XWalk2?	N/A
	Road Slope (%)	2.0		Clear Space?	N/A
	Road X Slope (%)	7.0	N/A	Clear Space to XWalk (in)	N/A
N/A	Any Obstructions?	N/A	N/A	Storm Grate/Utility Hazard?	N/A
	Obstruction Type			Storm Grate/Utility Type	
		N/A			N/A
			Yes	Surface Condition? (G/P)	Good
			No	Curb Slope (%)	11.8

Remove & Replace Curb Ramp With Two New Directional Ramps or Equivalent.
