Access Compliance Report Public Rights-of-Way (Curb Ramps)

Intersection ID: N/A	Main Street: CLANTON_RD	Cross Street: I-77_TO_CLANTON_RD	Location: SE
ADA ID: E8A1ECE27DB8	Ramp Type: Perp	Initial Pass/Fail: Fail	Overall Compliance: No Severity Score: 12.5

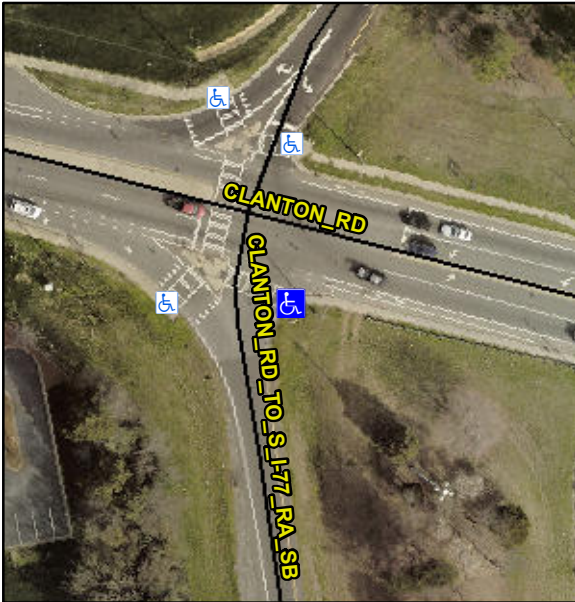
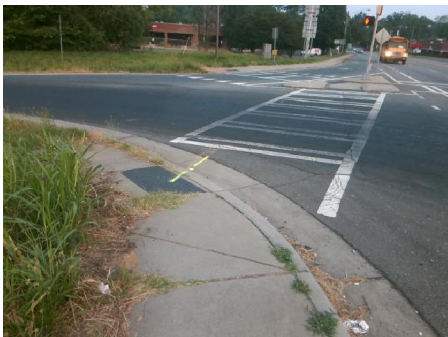
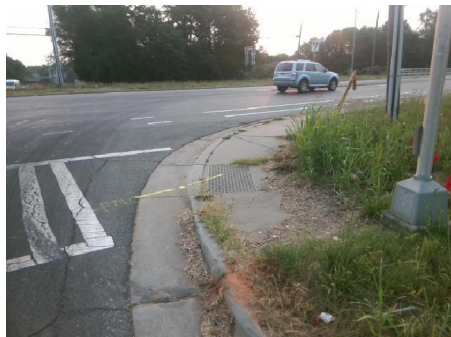
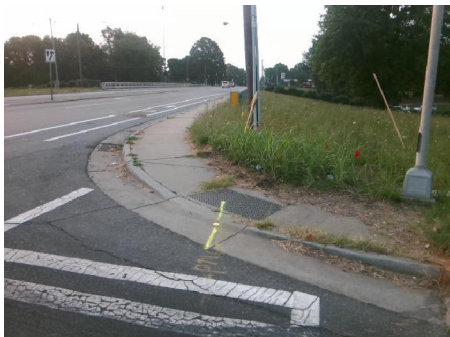
Not Found, R304.5.3

Compliance	Description	Data	Compliance	Description	Data
N/A	Ramp Length (in)	54.0	Yes	Ramp Slope (%)	5.7
Yes	Ramp Width (in)	49.0	No	Ramp XSlope (%)	5.9
N/A	Flare Type LT	N/A	N/A	Flare Type RT	N/A
N/A	Flare Slope LT (%)	N/A	N/A	Flare Slope RT (%)	N/A
N/A	Flare Traversable LT?	N/A	N/A	Flare Traversable RT?	N/A
N/A	Landing Length (in)	N/A	N/A	DWS Provided?	N/A
N/A	Landing Width (in)	N/A	N/A	DWS Contrast?	N/A
N/A	Landing Slope (%)	N/A	N/A	DWS Length (in)	N/A
N/A	Landing X Slope (%)	N/A	N/A	DWS Full Width?	N/A
N/A	Landing Curb? (Y/N)	N/A	N/A	DWS Offset (in)	N/A
N/A	Shared Landing?	N/A			
N/A	Gutter Ponding?	N/A	N/A	Gutter Slope (%)	N/A
N/A	Gutter Lip Ht (in)	N/A	N/A	Gutter X Slope (%)	N/A
N/A	Painted X Walk1?	Yes	N/A	Painted X Walk2?	N/A
	X Walk 1 Direction	To NW		X Walk 2 Direction	N/A
N/A	X Walk 1 Width (in)	112.0	N/A	X Walk 2 Width (in)	N/A
	X Walk 1 Slope (%)	2.1		X Walk 2 Slope (%)	N/A
	X Walk 1 X Slope (%)	4.8		X Walk 2 X Slope (%)	N/A

N/A	Ramp inside XWalk1?	Yes	N/A	Ramp inside XWalk2?	N/A
	Road Slope (%)	N/A	N/A	Clear Space?	N/A
	Road X Slope (%)	N/A	N/A	Clear Space to XWalk (in)	N/A
N/A	Any Obstructions?	N/A	N/A	Storm Grate/Utility Hazard?	N/A
	Obstruction Type			Storm Grate/Utility Type	
			N/A		N/A
			Yes	Surface Condition? (G/P)	Good

Remove & Replace Entire Ramp.
