# Access Compliance Report

## Public Rights-of-Way

### (Curb Ramps)

| Intersection ID: 2710 | Main Street: FAIRVISTA_DR | Cross Street: QUEENSBURY_CT | Location: SW |

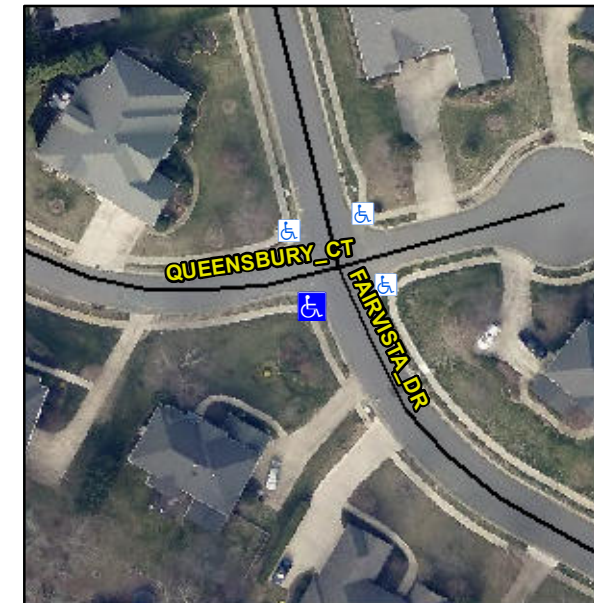
| ADA ID: E8B6FFBE683F | Ramp Type: PerpDiag | Initial Pass/Fail: Fail | Overall Compliance: No |

**Not Found, R304.5.1, R304.2.2, R304.5.3**

| Compliance | Description | Data | Compliance | Description | Data |
|---|---|---|---|---|---|
| N/A | Ramp Length (in) | 51.0 | No | Ramp Slope (%) | 10.8 |
| No | Ramp Width (in) | 41.0 | No | Ramp XSlope (%) | 5.4 |

**Remove & Replace Curb Ramp With Two New Directional Ramps or Equivalent.**

Total Cost: \$ 3200.00
