# Access Compliance Report

## Public Rights-of-Way

### (Curb Ramps)

Intersection ID: 46146	Main Street: ROCKY_FORD_CLUB_RD	Cross Street: BEAVER_CREEK_DR	Location: SW
ADA ID: E8BA0A96B56F	Ramp Type: PerpDiag	Initial Pass/Fail: Fail	Overall Compliance: No
Severity Score: 12.5			
Codes/Mitigation Info/Possible Solution		Field Measurements/Component Compliance

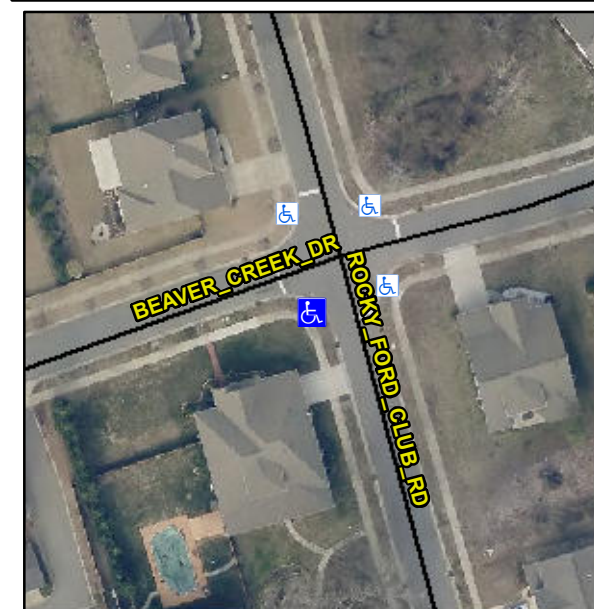
Compliance	Description	Data	Compliance	Description	Data
N/A	Ramp Length (in)	79.0	No	Ramp Slope (%)	11.0
Yes	Ramp Width (in)	48.0	Yes	Ramp XSlope (%)	0.1
N/A	Flare Type LT	N/A	N/A	Flare Type RT	N/A
N/A	Flare Slope LT (%)	N/A	N/A	Flare Slope RT (%)	N/A
N/A	Flare Traversable LT?	N/A	N/A	Flare Traversable RT?	N/A
N/A	Landing Length (in)	N/A	N/A	DWS Provided?	N/A
N/A	Landing Width (in)	N/A	N/A	DWS Contrast?	N/A
N/A	Landing Slope (%)	N/A	N/A	DWS Length (in)	N/A
N/A	Landing X Slope (%)	N/A	N/A	DWS Full Width?	N/A
N/A	Landing Curb? (Y/N)	N/A	N/A	DWS Offset (in)	N/A
N/A	Shared Landing?	N/A			
N/A	Gutter Ponding?	N/A	N/A	Gutter Slope (%)	N/A
N/A	Gutter Lip Ht (in)	N/A	N/A	Gutter X Slope (%)	N/A
N/A	Painted X Walk1?	No	N/A	Painted X Walk2?	No
	X Walk 1 Direction	To E		X Walk 2 Direction	To N
N/A	X Walk 1 Width (in)	N/A	N/A	X Walk 2 Width (in)	N/A
	X Walk 1 Slope (%)	2.8		X Walk 2 Slope (%)	0.4
	X Walk 1 X Slope (%)	0.7		X Walk 2 X Slope (%)	0.3

N/A	Ramp inside XWalk1?	N/A	N/A	Ramp inside XWalk2?	N/A
	Road Slope (%)	0.8	N/A	Clear Space?	N/A
	Road X Slope (%)	3.6	N/A	Clear Space to XWalk (in)	N/A
N/A	Any Obstructions?	N/A	N/A	Storm Grate/Utility Hazard?	N/A
	Obstruction Type			Storm Grate/Utility Type	
		N/A			N/A
			Yes	Surface Condition? (G/P)	Good

Possible Solutions:

**Remove & Replace Curb Ramp With Two New Directional Ramps or Equivalent.**
