Access Compliance Report

Public Rights-of-Way

(Curb Ramps)

Intersection ID: 16126	Main Street: E_W_T_HARRIS_BV	Cross Street: IDLEWILD_RD	Location: NW
ADA ID: E8BF5FA32616	Ramp Type: PerpDiag	Initial Pass/Fail: Fail	Overall Compliance: No
Severity Score: 21.25			
Codes/Mitigation Info/Possible Solution		Field Measurements/Component Compliance

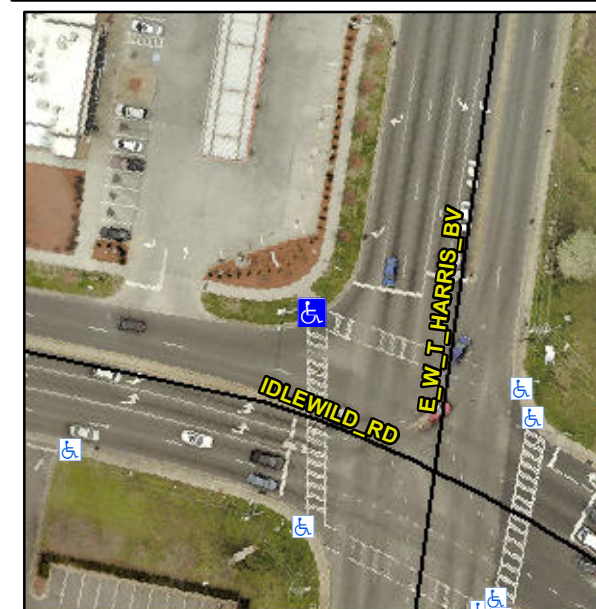
R304.5.1, R304.5.3

Compliance	Description	Data	Compliance	Description	Data
N/A	Ramp Length (in)	64.0	Yes	Ramp Slope (%)	6.0
No	Ramp Width (in)	47.0	No	Ramp XSlope (%)	5.2
N/A	Flare Type LT	N/A	N/A	Flare Type RT	N/A
N/A	Flare Slope LT (%)	N/A	N/A	Flare Slope RT (%)	N/A
N/A	Flare Traversable LT?	N/A	N/A	Flare Traversable RT?	N/A
N/A	Landing Length (in)	N/A	N/A	DWS Provided?	N/A
N/A	Landing Width (in)	N/A	N/A	DWS Contrast?	N/A
N/A	Landing Slope (%)	N/A	N/A	DWS Length (in)	N/A
N/A	Landing X Slope (%)	N/A	N/A	DWS Full Width?	N/A
N/A	Landing Curb? (Y/N)	N/A	N/A	DWS Offset (in)	N/A
N/A	Shared Landing?	N/A			
N/A	Gutter Ponding?	N/A	N/A	Gutter Slope (%)	N/A
N/A	Gutter Lip Ht (in)	1.0	N/A	Gutter X Slope (%)	N/A
N/A	Painted X Walk1?	Yes	N/A	Painted X Walk2?	Yes
	X Walk 1 Direction	To SW		X Walk 2 Direction	To SE
N/A	X Walk 1 Width (in)	111.0	N/A	X Walk 2 Width (in)	107.0
	X Walk 1 Slope (%)	0.4		X Walk 2 Slope (%)	2.6
	X Walk 1 X Slope (%)	4.0		X Walk 2 X Slope (%)	1.7

N/A	Ramp inside XWalk1?	Yes	N/A	Ramp inside XWalk2?	Yes
	Road Slope (%)	1.7	N/A	Clear Space?	N/A
	Road X Slope (%)	0.4	N/A	Clear Space to XWalk (in)	N/A
N/A	Any Obstructions?	N/A	N/A	Storm Grate/Utility Hazard?	N/A
	Obstruction Type			Storm Grate/Utility Type	
		N/A			N/A
		Yes		Surface Condition? (G/P)	Good

Remove & Replace Curb Ramp With Two New Directional Ramps or Equivalent.
