Access Compliance Report

Public Rights-of-Way

(Curb Ramps)

Intersection ID: 2842	Main Street: BEAUVISTA_DR	Cross Street: ELM_COVE_LN	Location: NE
ADA ID: E8C26A0C9C05	Ramp Type: PerpDiag	Initial Pass/Fail: Fail	Overall Compliance: No
Severity Score: 10			
Codes/Mitigation Info/Possible Solution		Field Measurements/Component Compliance

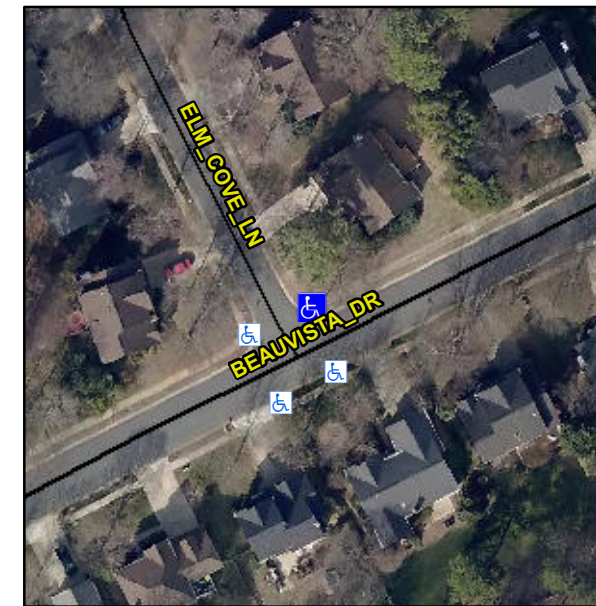
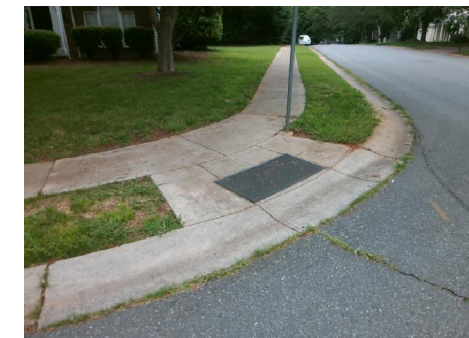
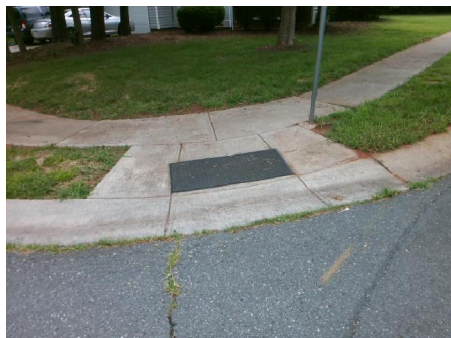
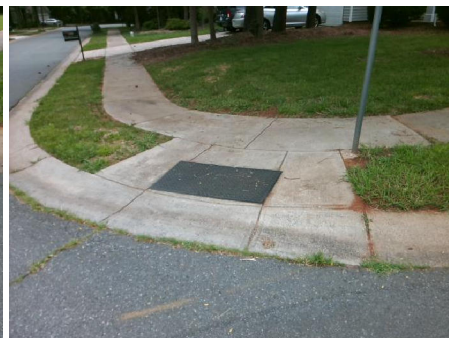
Not Found, R304.5.1, R304.5.3

Compliance	Description	Data	Compliance	Description	Data
N/A	Ramp Length (in)	47.0	Yes	Ramp Slope (%)	5.2
No	Ramp Width (in)	38.0	No	Ramp XSlope (%)	3.8
N/A	Flare Type LT	N/A	N/A	Flare Type RT	N/A
N/A	Flare Slope LT (%)	N/A	N/A	Flare Slope RT (%)	N/A
N/A	Flare Traversable LT?	N/A	N/A	Flare Traversable RT?	N/A
N/A	Landing Length (in)	N/A	N/A	DWS Provided?	N/A
N/A	Landing Width (in)	N/A	N/A	DWS Contrast?	N/A
N/A	Landing Slope (%)	N/A	N/A	DWS Length (in)	N/A
N/A	Landing X Slope (%)	N/A	N/A	DWS Full Width?	N/A
N/A	Landing Curb? (Y/N)	N/A	N/A	DWS Offset (in)	N/A
N/A	Shared Landing?	N/A			
N/A	Gutter Ponding?	N/A	N/A	Gutter Slope (%)	N/A
N/A	Gutter Lip Ht (in)	N/A	N/A	Gutter X Slope (%)	N/A
N/A	Painted X Walk1?	No	N/A	Painted X Walk2?	No
	X Walk 1 Direction	To W		X Walk 2 Direction	To S
N/A	X Walk 1 Width (in)	N/A	N/A	X Walk 2 Width (in)	N/A
	X Walk 1 Slope (%)	0.4		X Walk 2 Slope (%)	9.4
	X Walk 1 X Slope (%)	3.7		X Walk 2 X Slope (%)	1.7

N/A	Ramp inside XWalk1?	N/A	N/A	Ramp inside XWalk2?	N/A
	Road Slope (%)	4.8	N/A	Clear Space?	N/A
	Road X Slope (%)	4.4	N/A	Clear Space to XWalk (in)	N/A
N/A	Any Obstructions?	N/A	N/A	Storm Grate/Utility Hazard?	N/A
	Obstruction Type			Storm Grate/Utility Type	
		N/A			N/A
		Yes		Surface Condition? (G/P)	Good

Remove & Replace Curb Ramp With Two New Directional Ramps or Equivalent.
