Access Compliance Report

Public Rights-of-Way

(Curb Ramps)

Intersection ID: 2658	Main Street: CRESTWICK_CT	Cross Street: FAIRVISTA_DR	Location: SE
ADA ID: E8CD6D7D50C0	Ramp Type: Perp	Initial Pass/Fail: Fail	Overall Compliance: No
		Severity Score: 12.5

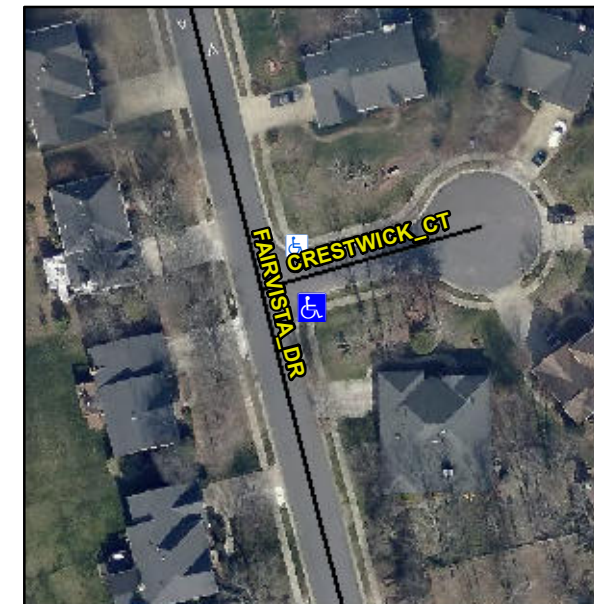
Not Found, R304.2.2

Compliance	Description	Data	Compliance	Description	Data
N/A	Ramp Length (in)	48.0	No	Ramp Slope (%)	11.1
Yes	Ramp Width (in)	48.0	Yes	Ramp XSlope (%)	2.0
N/A	Flare Type LT	N/A	N/A	Flare Type RT	N/A
N/A	Flare Slope LT (%)	N/A	N/A	Flare Slope RT (%)	N/A
N/A	Flare Traversable LT?	N/A	N/A	Flare Traversable RT?	N/A
N/A	Landing Length (in)	N/A	N/A	DWS Provided?	N/A
N/A	Landing Width (in)	N/A	N/A	DWS Contrast?	N/A
N/A	Landing Slope (%)	N/A	N/A	DWS Length (in)	N/A
N/A	Landing X Slope (%)	N/A	N/A	DWS Full Width?	N/A
N/A	Landing Curb? (Y/N)	N/A	N/A	DWS Offset (in)	N/A
N/A	Shared Landing?	N/A			
N/A	Gutter Ponding?	N/A	N/A	Gutter Slope (%)	N/A
N/A	Gutter Lip Ht (in)	N/A	N/A	Gutter X Slope (%)	N/A
N/A	Painted X Walk1?	No	N/A	Painted X Walk2?	N/A
	X Walk 1 Direction	To N		X Walk 2 Direction	N/A
N/A	X Walk 1 Width (in)	N/A	N/A	X Walk 2 Width (in)	N/A
	X Walk 1 Slope (%)	0.1		X Walk 2 Slope (%)	N/A
	X Walk 1 X Slope (%)	2.4		X Walk 2 X Slope (%)	N/A

N/A	Ramp inside XWalk1?	N/A	N/A	Ramp inside XWalk2?	N/A
	Road Slope (%)	N/A	N/A	Clear Space?	N/A
	Road X Slope (%)	N/A	N/A	Clear Space to XWalk (in)	N/A
N/A	Any Obstructions?	N/A	N/A	Storm Grate/Utility Hazard?	N/A
	Obstruction Type			Storm Grate/Utility Type	
		N/A			N/A
			Yes	Surface Condition? (G/P)	Good

Remove & Replace Entire Ramp.
