# Access Compliance Report

## Public Rights-of-Way

### (Curb Ramps)

Intersection ID: 10024336	Main Street: CREEKRIDGE_RD	Cross Street: N/A	Location: S
ADA ID: E8D29556DBC8	Ramp Type: PerpDiag	Initial Pass/Fail: Fail	Overall Compliance: No
		Severity Score: 12.5

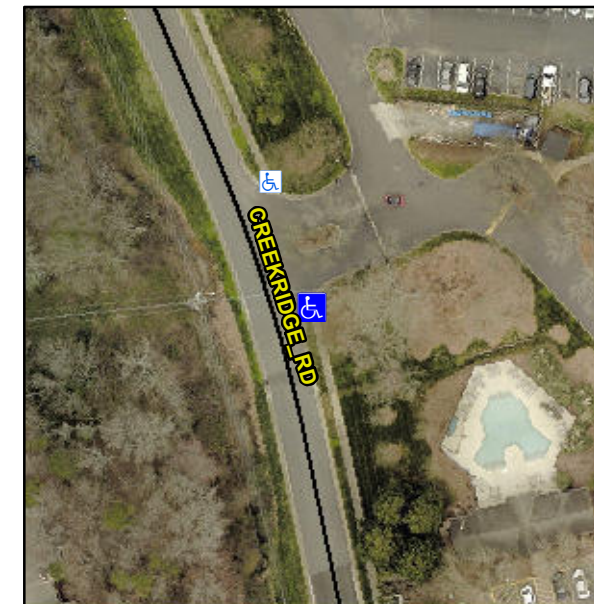
Compliance	Description	Data	Compliance	Description	Data
N/A	Ramp Length (in)	36.0	No	Ramp Slope (%)	11.0
Yes	Ramp Width (in)	48.0	Yes	Ramp XSlope (%)	0.5
N/A	Flare Type LT	N/A	N/A	Flare Type RT	N/A
N/A	Flare Slope LT (%)	N/A	N/A	Flare Slope RT (%)	N/A
N/A	Flare Traversable LT?	N/A	N/A	Flare Traversable RT?	N/A
N/A	Landing Length (in)	N/A	N/A	DWS Provided?	N/A
N/A	Landing Width (in)	N/A	N/A	DWS Contrast?	N/A
N/A	Landing Slope (%)	N/A	N/A	DWS Length (in)	N/A
N/A	Landing X Slope (%)	N/A	N/A	DWS Full Width?	N/A
N/A	Landing Curb? (Y/N)	N/A	N/A	DWS Offset (in)	N/A
N/A	Shared Landing?	N/A			
N/A	Gutter Ponding?	N/A	N/A	Gutter Slope (%)	N/A
N/A	Gutter Lip Ht (in)	N/A	N/A	Gutter X Slope (%)	N/A
N/A	Painted X Walk1?	No	N/A	Painted X Walk2?	No
	X Walk 1 Direction	To N		X Walk 2 Direction	To W
N/A	X Walk 1 Width (in)	N/A	N/A	X Walk 2 Width (in)	N/A
	X Walk 1 Slope (%)	2.1		X Walk 2 Slope (%)	1.4
	X Walk 1 X Slope (%)	6.0		X Walk 2 X Slope (%)	2.3

N/A	Ramp inside XWalk1?	N/A	N/A	Ramp inside XWalk2?	N/A
	Road Slope (%)	6.3	N/A	Clear Space?	N/A
	Road X Slope (%)	2.3	N/A	Clear Space to XWalk (in)	N/A
N/A	Any Obstructions?	N/A	N/A	Storm Grate/Utility Hazard?	N/A
	Obstruction Type			Storm Grate/Utility Type	
		N/A			N/A
			Yes	Surface Condition? (G/P)	Good

**Remove & Replace Curb Ramp With Two New Directional Ramps or Equivalent.**
