# Access Compliance Report

## Public Rights-of-Way

### (Curb Ramps)

Intersection ID: N/A	Main Street: BALLANTYNE CORPORATE PL	Cross Street: N/A	Location: NW
ADA ID: E8D4475A3430	Ramp Type: Directional	Initial Pass/Fail: Fail	Overall Compliance: No
Severity Score: 10			
Codes/Mitigation Info/Possible Solution		Field Measurements/Component Compliance

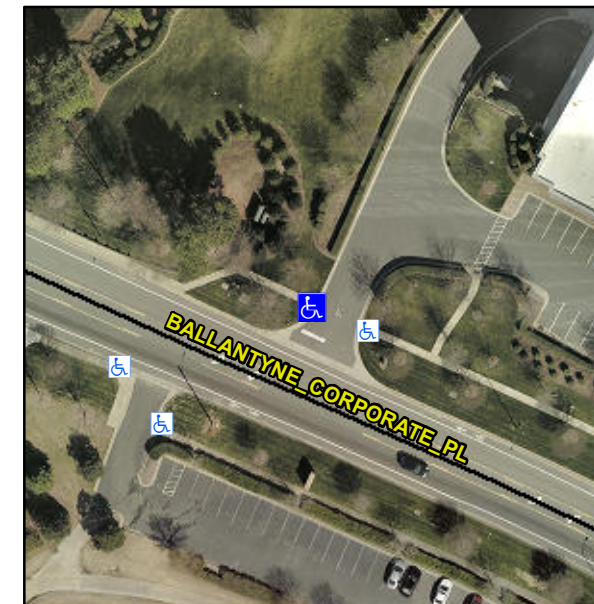
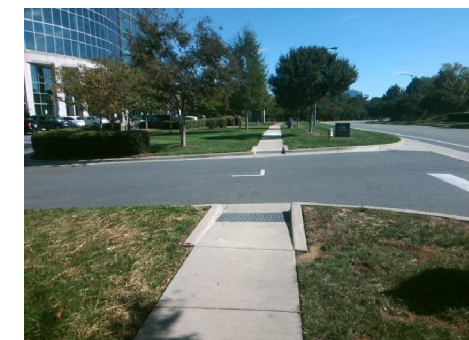
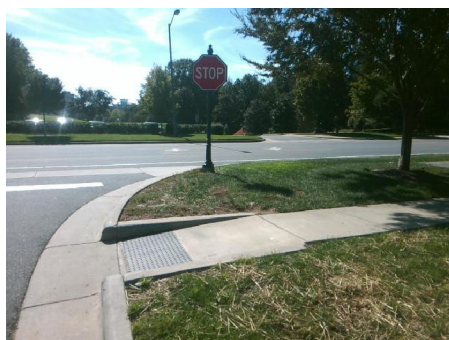
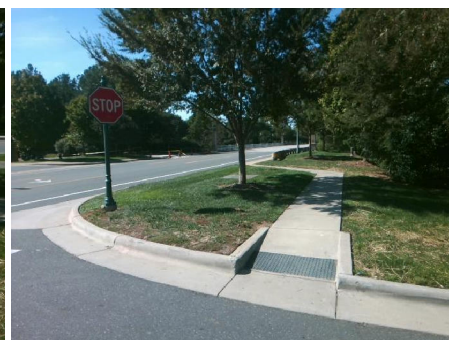
**R304.5.1, R304.5.3**

Compliance	Description	Data	Compliance	Description	Data
N/A	Ramp Length (in)	73.0	N/A	Grade Break?	N/A
No	Ramp Width (in)	45.0	N/A	Grade Break Slope (%)	0.0
Yes	Ramp Slope (%)	6.4	N/A	Grade Break XSlope (%)	0.0
No	Ramp XSlope (%)	2.5			
N/A	Flare Type LT	N/A	N/A	Flare Type RT	N/A
N/A	Flare Slope LT (%)	N/A	N/A	Flare Slope RT (%)	0.0
N/A	Flare Traversable LT?	N/A	N/A	Flare Traversable RT?	N/A
N/A	Landing Length (in)	0.0	N/A	DWS Provided?	N/A
N/A	Landing Width (in)	0.0	N/A	DWS Contrast?	N/A
N/A	Landing Slope (%)	0.0	N/A	DWS Length (in)	N/A
N/A	Landing X Slope (%)	0.0	N/A	DWS Full Width?	N/A
N/A	Landing Curb? (Y/N)	N/A	N/A	DWS Offset LT (in)	N/A
N/A	Shared Landing?	N/A	N/A	DWS Offset RT (in)	N/A
N/A	Gutter Ponding?	0.0	N/A	Gutter Slope (%)	N/A
N/A	Gutter Lip Ht (in)	0.0	N/A	Gutter X Slope (%)	N/A
N/A	Painted X Walk1?	No		Road Slope (%)	1.3
	X Walk 1 Direction	To SE		Road X Slope (%)	2.9
	X Walk 1 Width (in)	N/A		Clear Space?	N/A

X Walk 1 Slope (%)	1.3	N/A	Clear Space to XWalk (in)	N/A
	X Walk 1 X Slope (%)	2.9	N/A	Storm Grate/Utility Hazard?	N/A
N/A	Ramp inside XWalk1?	N/A		Storm Grate/Utility Type	
N/A	Any Obstructions?	N/A			N/A
	Obstruction Type		Yes	Surface Condition? (G/P)	Good
			N/A	Curb Slope (%)	11.7

**Remove & Replace Entire Ramp.**

Total Cost: \$ 1600.00
